TRANSIT ORIENTED DEVELOPMENT PLAN: HISTORIC PRESERVATION PLAN
LAWRENCE TO BRYN MAWR MODERNIZATION

West Argyle Street Historic District

July 2018

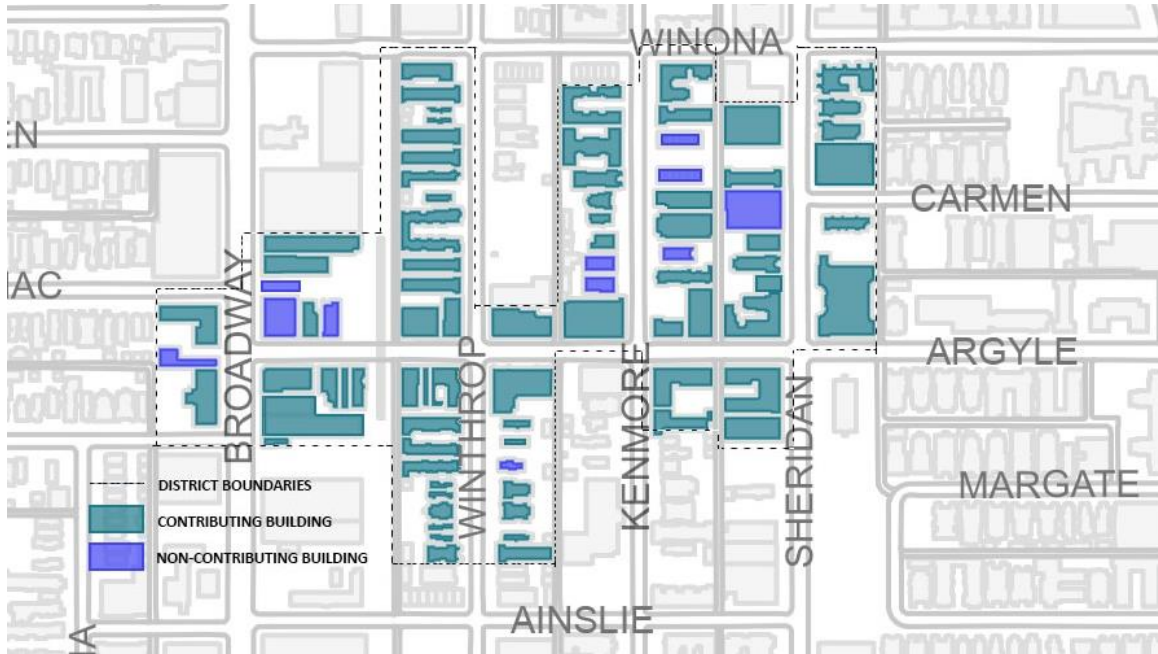
CURRENT MAP OF THE DISTRICT

Maps of the district are provided on the next page. The first map identifies the contributing and non-contributing properties in the district. The second map identifies each building in the district by decade of construction.

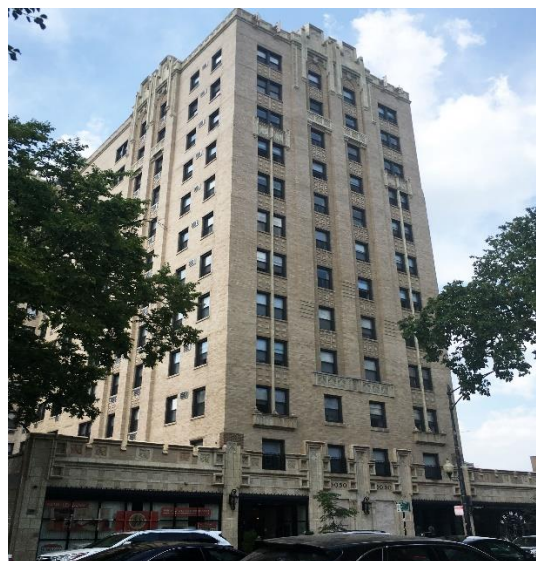
Example of Late Gothic Revival in the district.

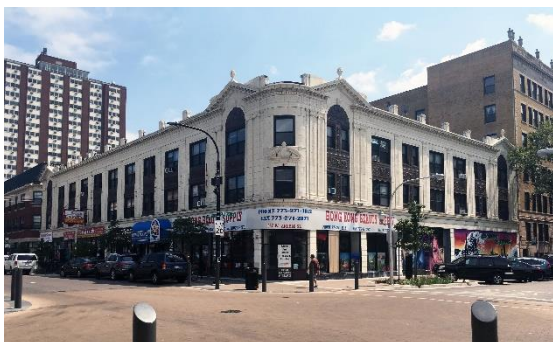
Late Classical Revival is inspired by stylistic details of the Greek Revival style. Classical Revival style buildings often have massive columns with classical capitals, topped by a front facing pediment. The Late Classical Revival style was frequently used for civic, institutional and commercial buildings, and applied to residential buildings in Chicago. Typical architectural characteristics can include symmetrical façades; smooth masonry exterior surfaces; a prominent centered pediment; semi-circular transom above the paneled front door; broken pediment over the entry door; and modillions and dentils lining the cornice. There are 42 buildings or 48.3% of the district identified as Late Classical Revival.

Example of Late Classical Revival in the district.

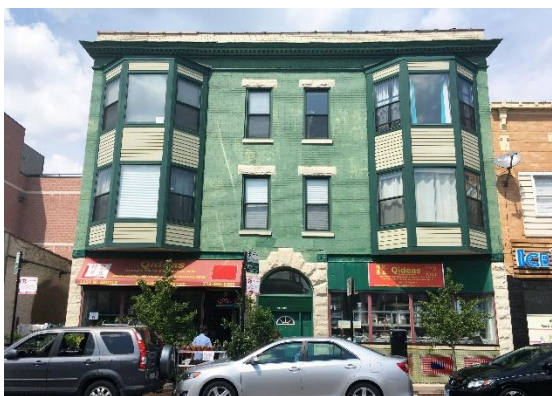
For many, the Queen Anne style typifies the architecture of the Victorian era. This popular style of the 1880s and 1890s has asymmetrical massing characterized by projecting bays and prominent, compound roof shapes. Buildings were typically clad in a variety of materials and with multiple textures including patterned shingles. In this district, buildings are masonry and characterized by large, heavy proportional front bays. Typical architectural characteristics can include decorative spindlework and gable trim; projecting pressed metal bays; turrets or conical towers; irregular roofline with many dormers and chimneys; and single pane windows, some paired, with small decorative panes or stained glass. There are 4 buildings or 4.6% of the district identified as Queen Anne.

Example of Queen Anne in the district.

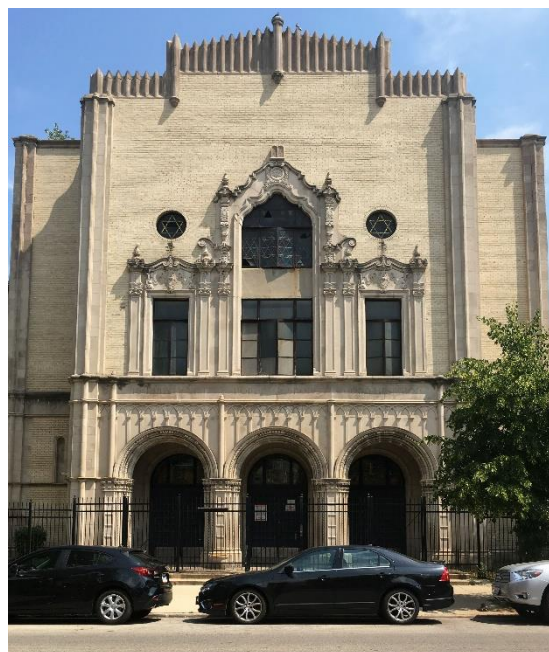
Buildings in the Romanesque Revival style are always heavy, massive masonry construction, usually with some rough-faced stonework. Wide, rounded arches in Roman or Romanesque architecture are an important identifying feature, often resting on squat columns. Frequently, decorative floral detail appears in the stonework, and sometimes on column capitals. Typical architectural characteristics can include masonry construction; round arches at entrance windows; heavy and massive appearance; polychromatic stonework details; round towers; squat columns; and decorative plaques. There is 1 building or 1.2% of the district identified as Romanesque Revival.

Example of Romanesque Revival in the district.

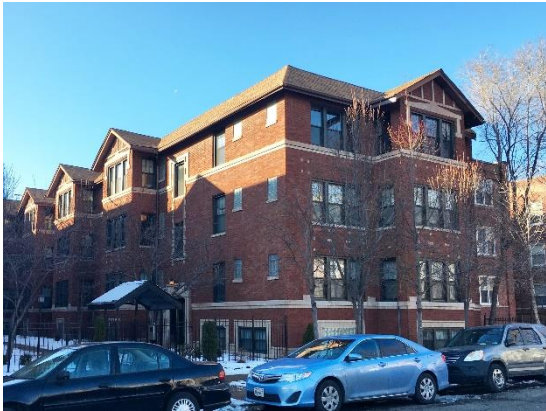
A popular romantic revival style from the first half of the twentieth century, Tudor Revival was inspired by English Medieval architecture. The style is recognized by steeply pitched side gabled or hipped roofs, with one or more front facing, asymmetrically placed gables. Tudor Revival also features masonry, brick, or stucco with half-timbering walls; rounded Tudor arch door openings; multiple and overlapping dormers; massive chimneys, often stone or stucco with stone ornament; and steeply pitched roofs. Windows are tall and narrow, either double hung or casement, often with decorative leaded glass and stone mullions and trim. There are 8 buildings or 9.2% of the district identified as Tudor Revival.

Example of the Tudor Revival style in the district.

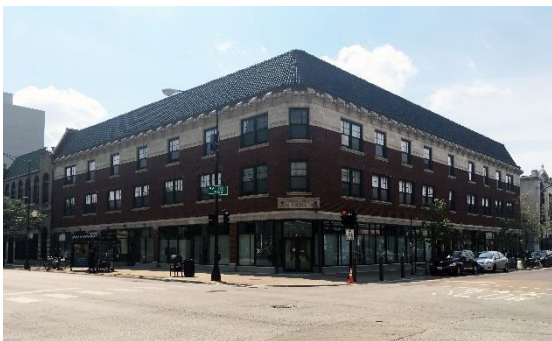
The Italian Renaissance Revival style developed at the end of the nineteenth century and was inspired by Italy and the ancient world. This style has a studied formalism, symmetrical composition, rectangular forms, simple flat façades, and low-pitched roofs and architectural features including: restrained decoration; minimal use of columns or decoration at the entry; wide roof overhangs; rounded roof tiles; and roof line parapets or balustrades. There are 4 buildings or 4.6% of the district identified as Italian Renaissance Revival.

Example of Italian Renaissance Revival in the district.

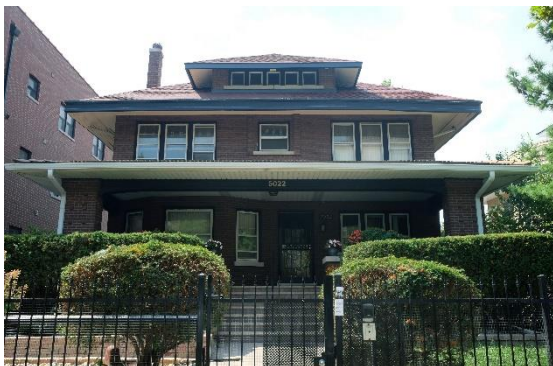
Typical architectural characteristics can include simple box shape; two or two and half stories tall; two to three bays wide; four-room floor plan; low-hipped roof with deep overhang; large central dormer; full-width porch with wide stairs; and brick, stone, stucco, concrete block, or wood siding. There are 2 buildings or 2.2% of the district identified as Craftsman.

Example of Craftsman American Foursquare in the district.

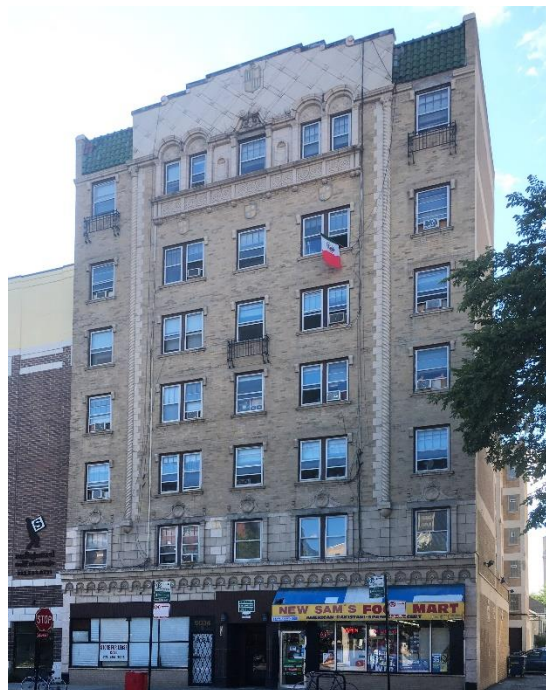
The Spanish Eclectic style, also known as the Spanish Colonial Revival style, results from the traditional Spanish architectural themes of Spain's American colonial settlements. Other architectural details may be derived from later periods of Spanish architecture and reference Moorish, Byzantine, Gothic, or Renaissance designs. This revival style debuted to a national audience at the Panama-California Exposition, held in San Diego in 1915. Architectural characteristics can include low-pitched, clay tile roof, rounded arches, low-relief carving at doorways, windows and cornices, elaborately carved doors; decorative window grills of wood or iron; spiral columns; multi-paned windows; balconies or terraces, and a curvilinear gable. There are 4 buildings or 4.6% of the district identified as Spanish Eclectic.

Example of Spanish Eclectic in the district.

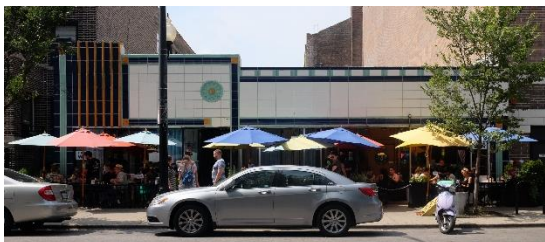
The Art Deco style is defined by its characteristic sharp-edges and stylized geometrical details. Its name was derived from the Exposition Internationale des Arts Décoratifs et Industriels Modernes, held in Paris in 1925, where the style was first exhibited, as an intentional break with past precedents. Typical architectural characteristics include: low-relief decorative panels at the entrances, around windows, along roof edges or as string courses; smooth building materials such as stucco, concrete block, glazed brick or mosaic tile; stylized decorative elements using geometrical forms, zigzags, chevrons; strips of windows with decorative spandrels; and reeding and fluting around doors and windows. There is 1 building or 1.2% of the district identified as Art Deco.

Example of Art Deco in the district.

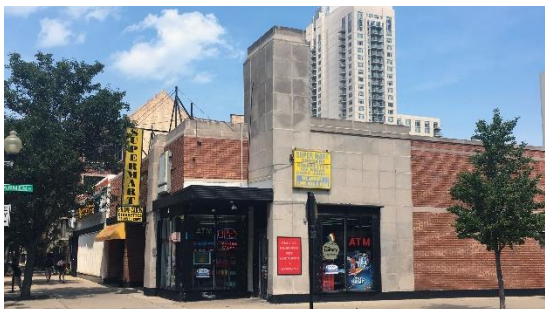
Mid-Century Modern design dominated mid-twentieth century American architecture and became increasingly popular after World War II. Designers simplified architecture to its most essential form. Architects experimented with materials such as poured concrete, rather than just steel and glass, and used various prefabricated methods of construction. This style is defined by clean, linear, and sweeping lines, either straight or angled; no applied ornamentation, innovative uses and large expanses of glass exterior walls, a mixture of various materials, and flat roofs. There is 1 building or 1.2% of the district identified as Mid-Century Modern.

Example of Mid-Century Modern in the district.

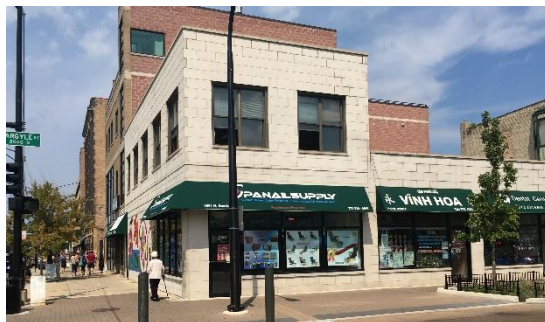
This style was favored for architect-designed buildings constructed between 1945 and 1990. The contemporary style is simple and predominately features flat wall and roof planes without applied ornamentation; natural materials wood, brick, and stone; broad expanse of uninterrupted wall surface; and the absence of traditional detailing. There are 7 buildings or 8% of the district identified as Contemporary.

Example of Contemporary in the district.

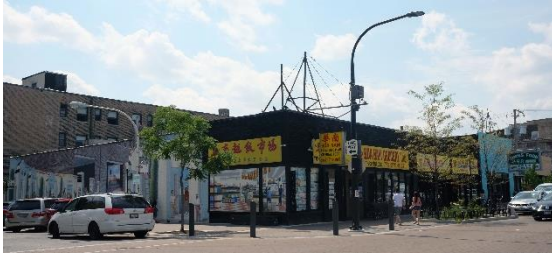
projecting cornice or other strong horizontal design element dividing the first floor from the upper floors.

Example of a typical One-Part Commercial Block in the district.

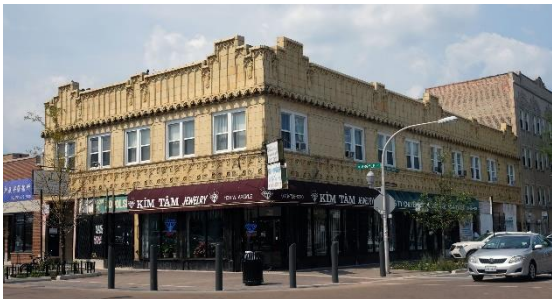
A two-part commercial block is generally limited to structures of two to four stories, this type is characterized by a horizontal division into two distinct zones. The two-part division reflects the separation of uses on the interior, with more public uses found at the street level and private uses such as offices or residences located on the upper levels. The buildings are located at the front of lot lines, along public sidewalks, and have display windows facing that sidewalk. Side walls are typically party walls and usually do not have display windows, public entrances, or architectural treatment. Occasionally, larger or corner commercial blocks may have part or all the side façades treated similarly to the front.

Example of a typical Two-Part Commercial Block in the district.

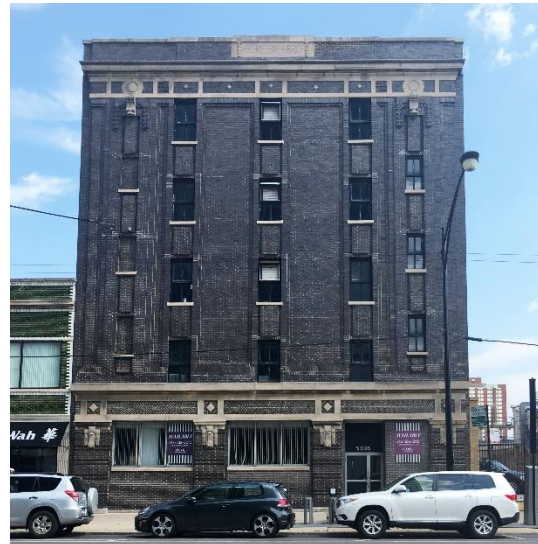
These buildings, and the Reebie Brothers Storage building (5035 N. Broadway), represent the two-part vertical block used in the late nineteenth century as a means of simplifying the exterior of tall, commercial buildings. On the two-part vertical block, the façade is divided horizontally into two major zones that are different but carefully related to one another to create a unified whole. The lower zone rises one or two stories and serves as a visual base of the dominant "shaft", or upper zone. The two-part vertical block must be at least four stories in height to possess a sufficient sense of verticality.

Example of a typical Two-Part Vertical Block in the district.

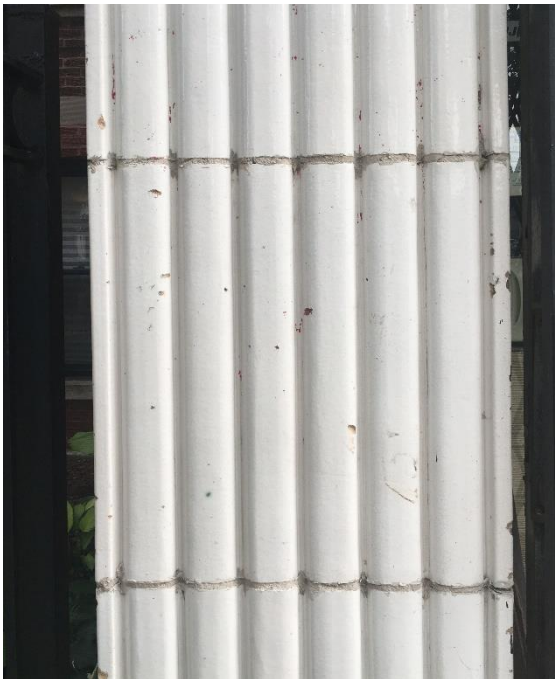
Example of terra cotta cladding in the district.

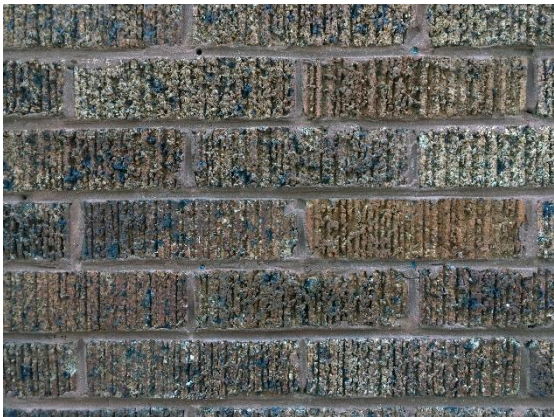
Example of brick cladding in the district.

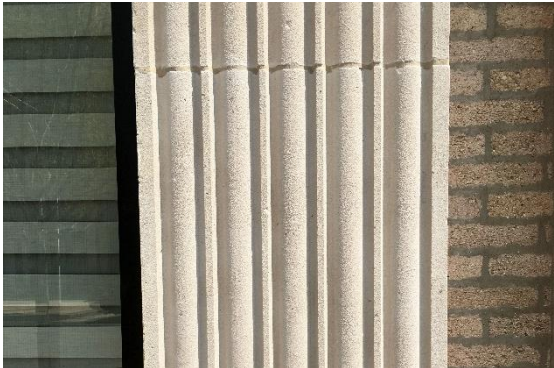
Example of limestone cladding in the district.

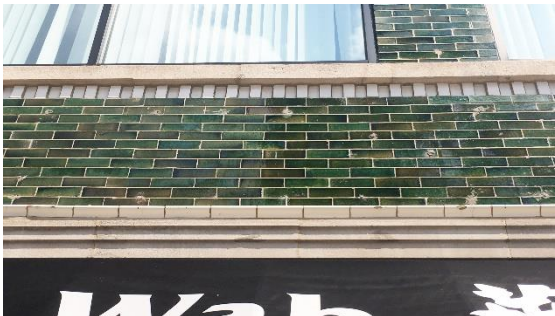
Example of glazed brick in the district.

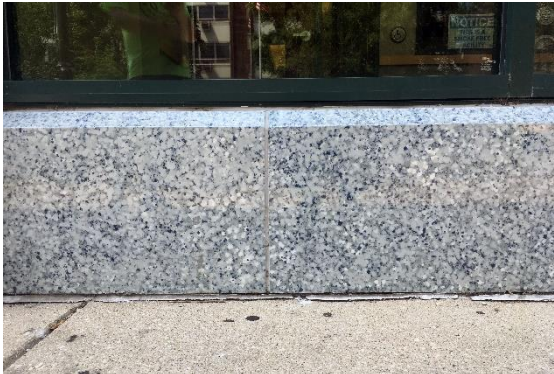
Example of granite cladding in the district.

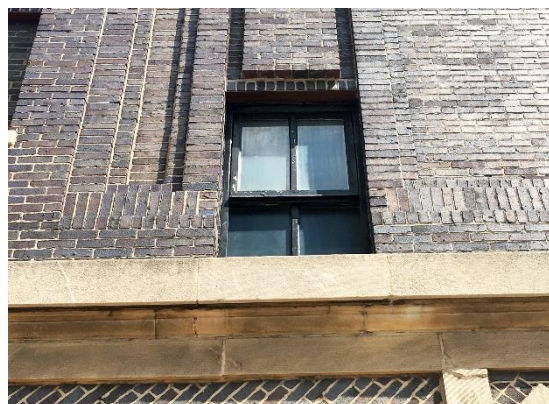
Example of a historic wood sash window in the district.

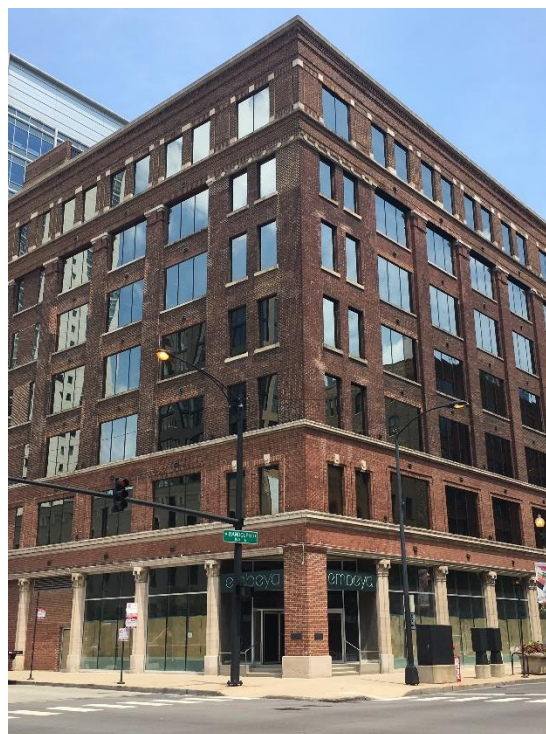
Example of an inappropriate use of mirrored glass windows on a historic building not in the district.

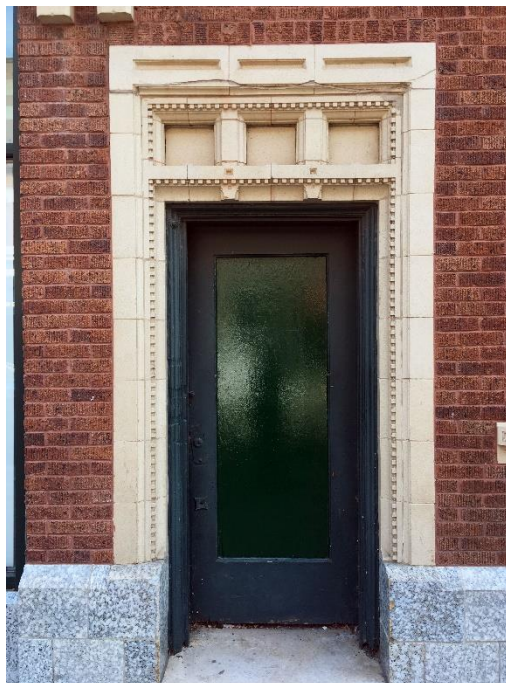
Example of a historic residential entry door in the district, with an intact, original opening.

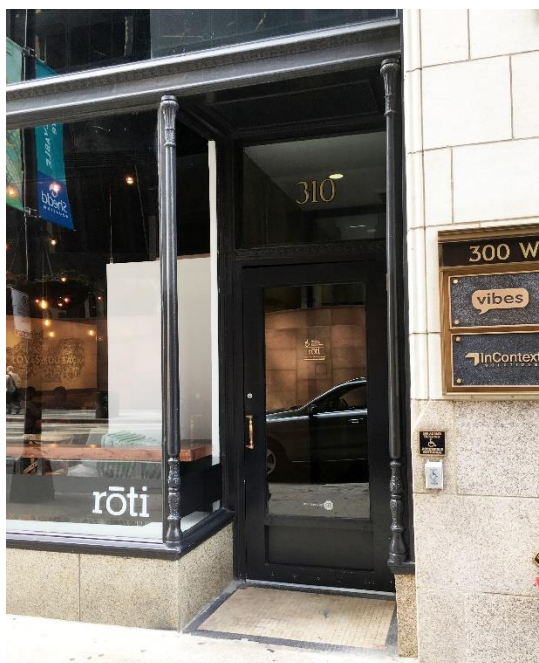
Example of a contemporary door type that is appropriate to this historic building not in the district.

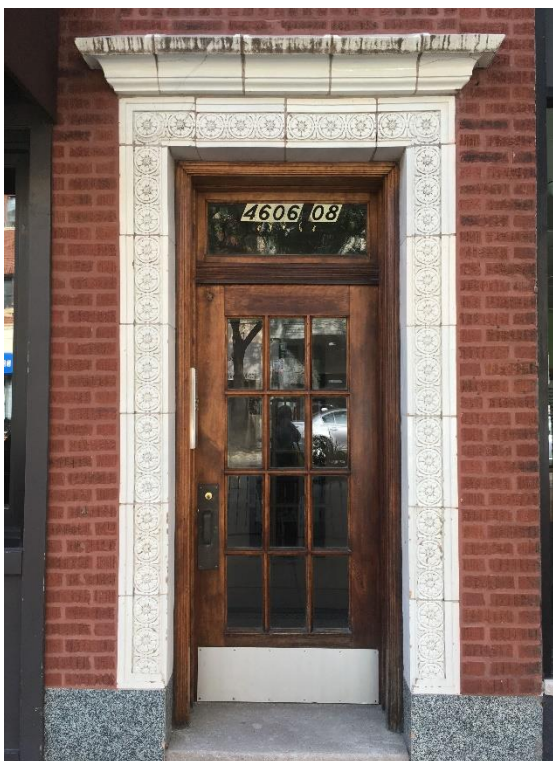
Example of a historic door and transom not in the district.

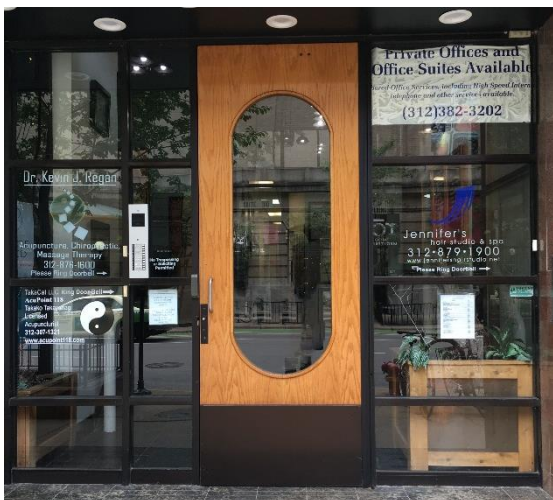
Example of an inappropriate contemporary replacement door and opening not in the district.

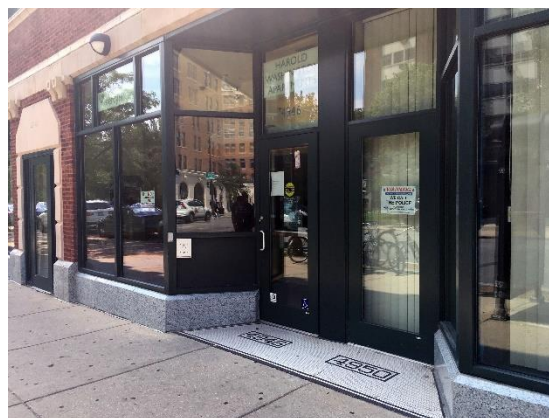
Example of a typical contemporary, historically-appropriate storefront in the district with historic exterior tile entrance.

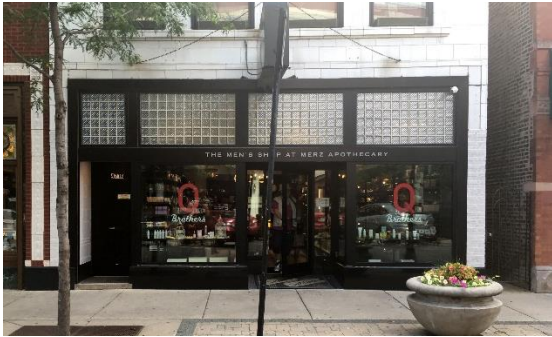
Example of an appropriate contemporary interpretation of a historic storefront not in the district.

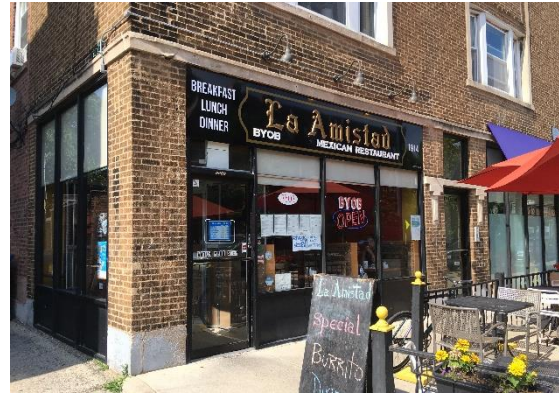
Example of an inappropriate contemporary storefront alteration not in the district. The original storefront would have been recessed.

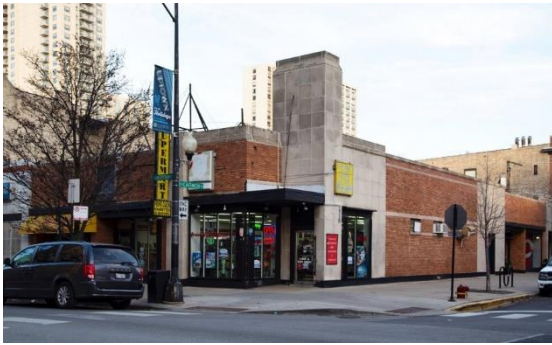
Example of an intact mid-twentieth century storefront with few contemporary alterations in the district

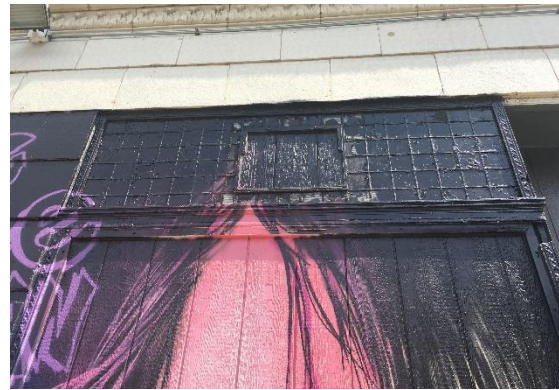
Example of historic prism glass storefront transom, evident under the paint, in the district. Prism glass was introduced in the 1890s as a popular and practical way of directing daylight into building interiors. The glass had ridges or other raised patterns on the inside surface that refracted sunlight toward the rear of the building.

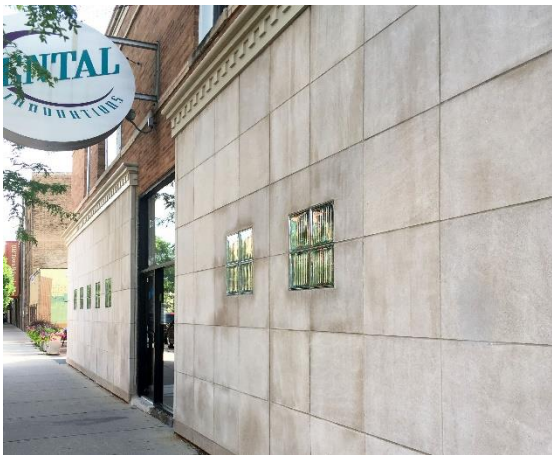
Example of an inappropriate, contemporary storefront alteration not in the district. Incompatible limestone veneer has been applied to the original storefront and glass block windows installed which are disproportionate in size, type, and material.

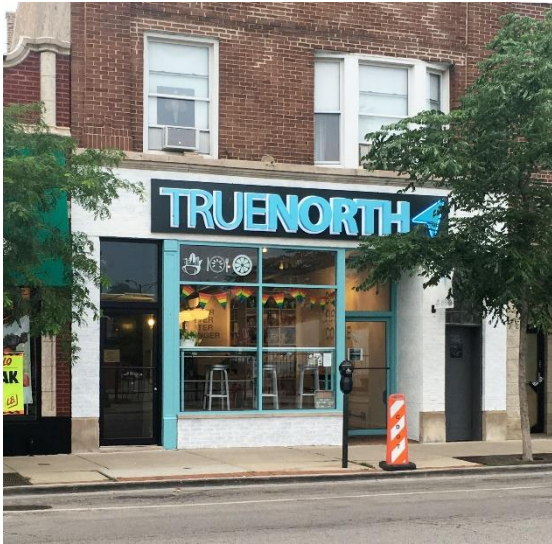
Example of a storefront, located outside of the district. It is inappropriate due to the painted brick cladding and reconfigured storefront, but has preserved some original elements, including the brick and limestone bulkhead and a cast iron column (painted blue).

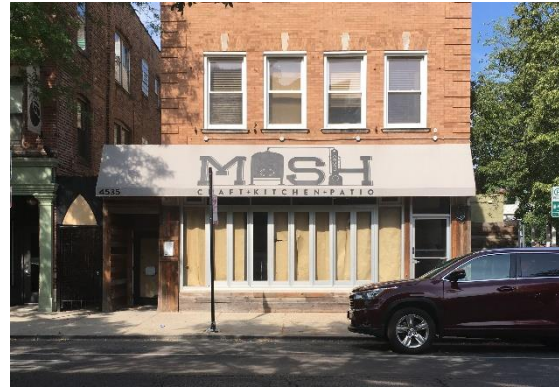
Example of an incompatible alteration to the storefront design and window type not in the district.

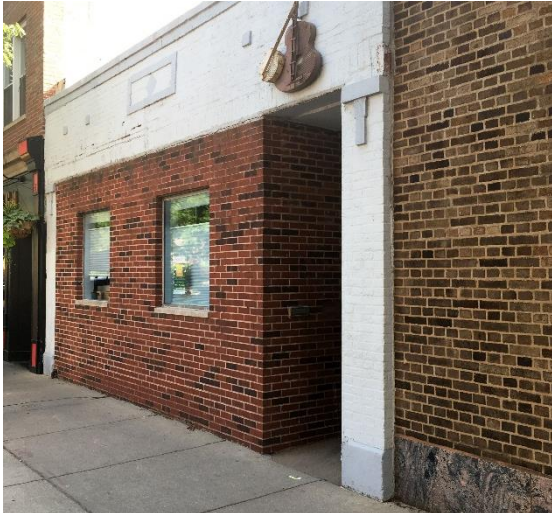
Example of an inappropriate contemporary storefront alteration, outside of the district, where the historic storefront has been infilled with brick.

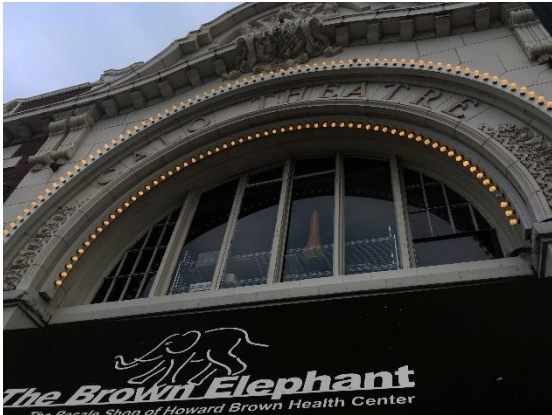
Example of historic architectural lighting not in the district.

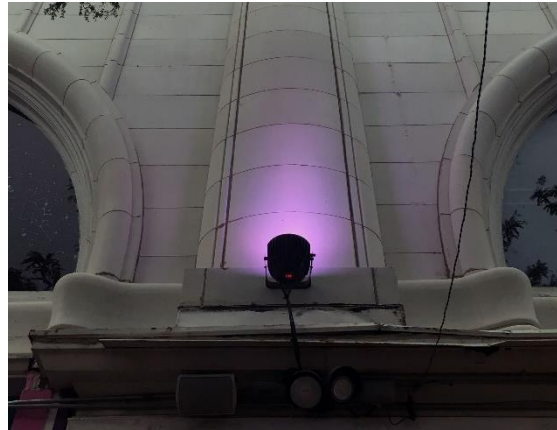
Example of contemporary architectural lighting, located outside of the district, that appropriately lights an architectural feature, but is not concealed.

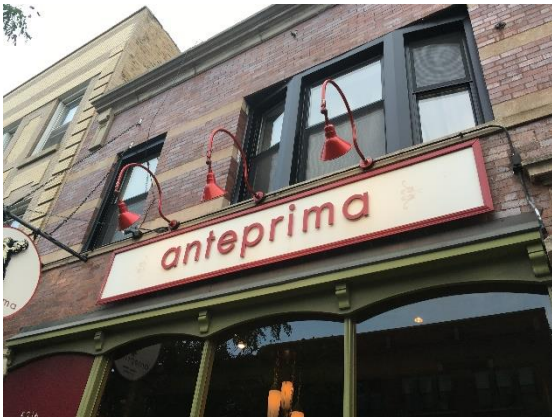
Example of inappropriate gooseneck exterior lighting and exposed conduit not in the district.

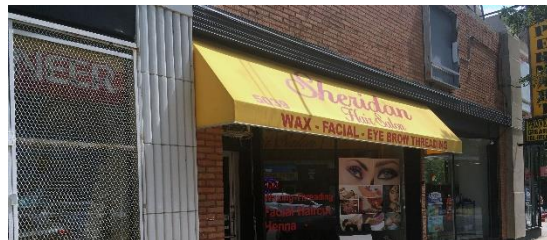
Example of a historically-appropriate "standard" awning in the district.

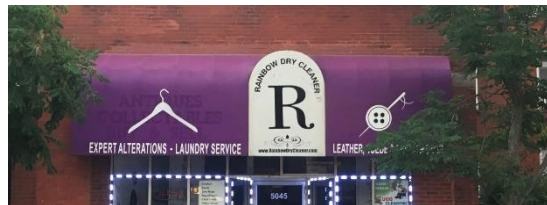
Example of an inappropriate contemporary "waterfall" awning, located outside of the district.

- Waterfall, concave, box or other exaggerated shaped awnings or canopies are discouraged as they are not appropriate.
- Signage on awnings should be limited to valance area.

- Internally illuminated awnings or canopies are discouraged in the district.

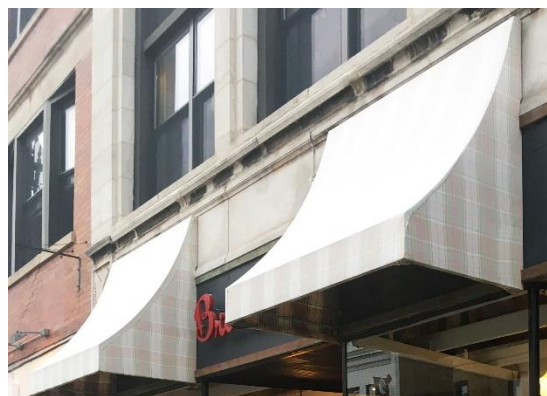
Example of an inappropriate contemporary "concave" awning, located outside of the district.

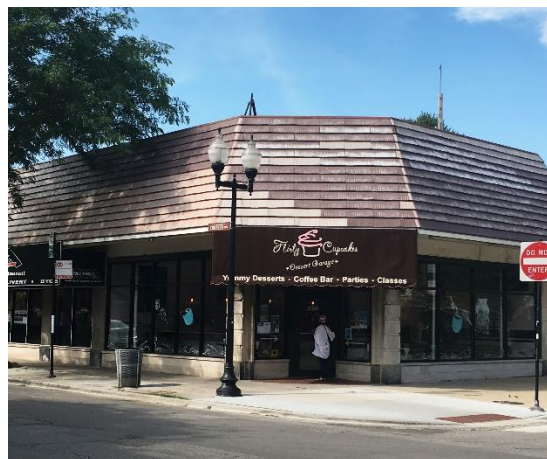
Example of an inappropriate contemporary "box" awning, located outside of the district.

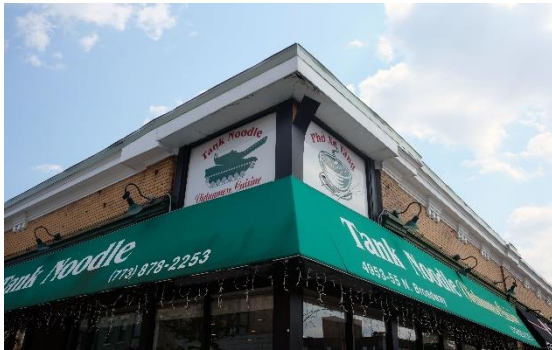
Example of historically-appropriate signage integrated into a façade in the district.

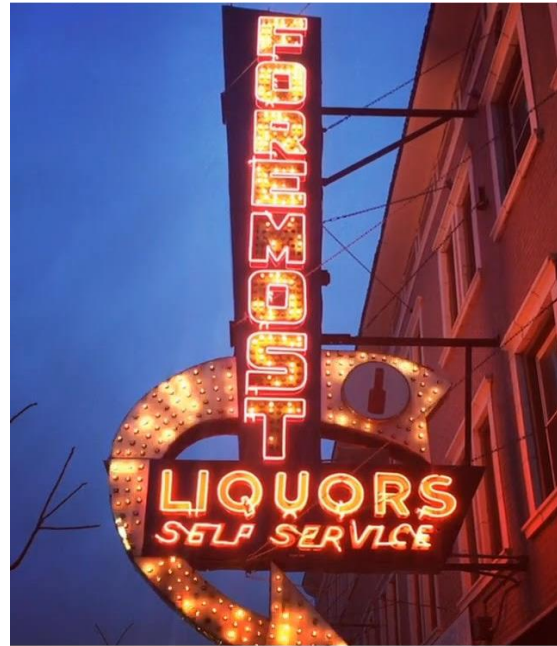
Example of a historic neon projecting sign in the district.

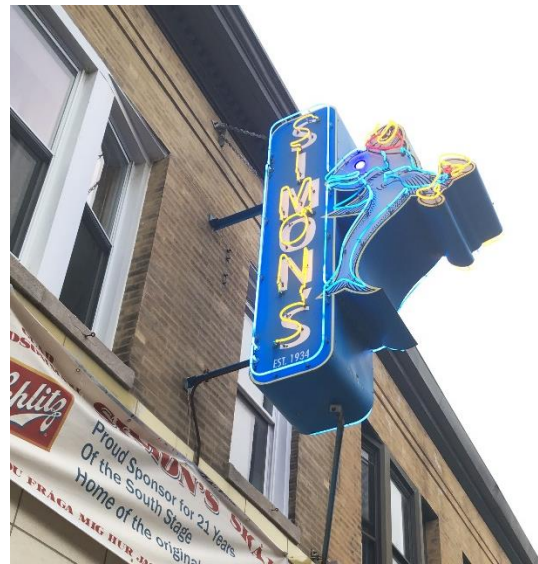
Example of a well-maintained historic neon sign not in the district.

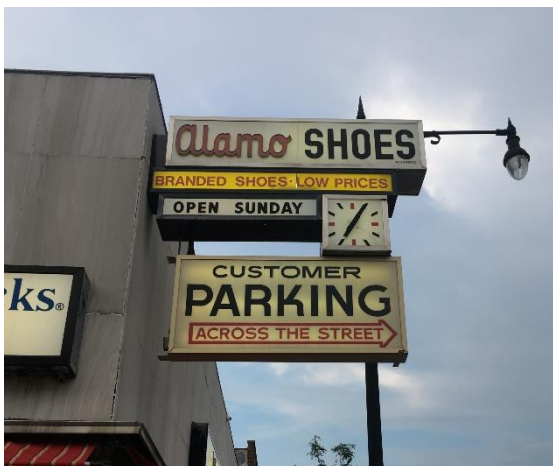
Example of a well-maintained historic projecting sign not in the district.

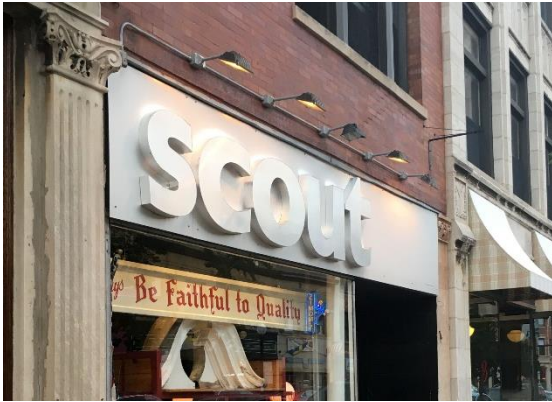
Example of an inappropriate contemporary sign not in the district. The letters are disproportionately scaled and obscure the historic storefront/transom configuration.

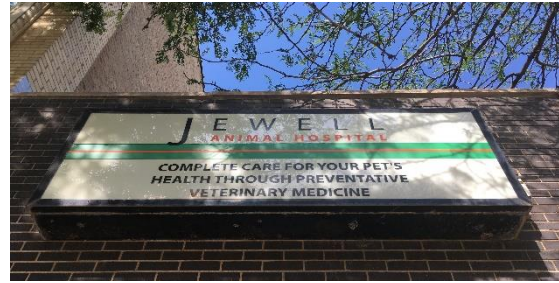
Example of an inappropriate box sign not in the district. This sign is not integrated into the design of the building, obscures a larger portion of the main façade, and is mounted directly into the brick.

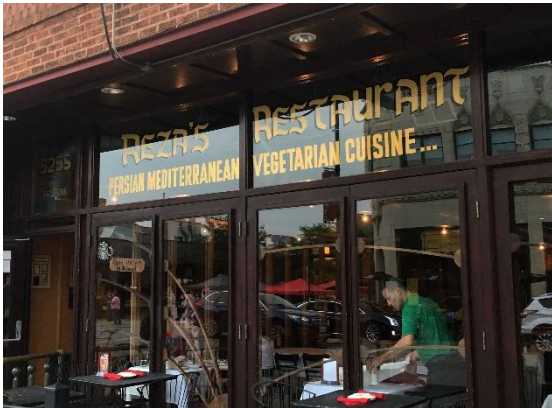
Example of appropriate gold leaf signage not in the district. Gold leaf lettering has been used since the mid-to-late-nineteenth century on storefront display windows and entrances or on wooden projecting signs for lettering.

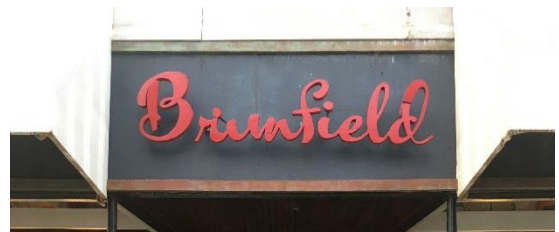
Example of appropriate contemporary, minimalistic signage not in the district.

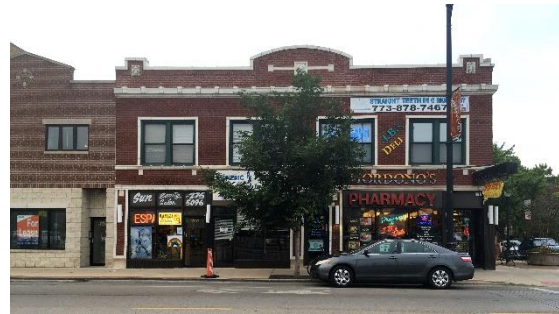
Example of inappropriate excessive signage and signage mounted to brick not in the district.

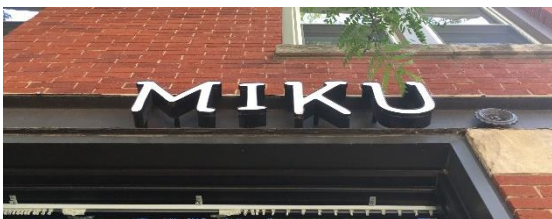
Example of inappropriate sign mounting, located outside of the district, as the sign is directly attached to the historic cast iron header.

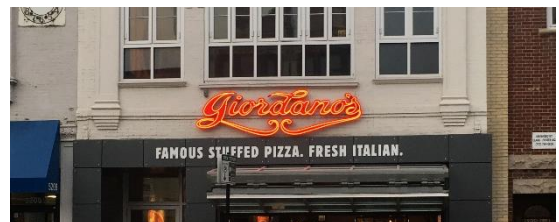
Example of appropriate contemporary signage, located outside of the district, that is appropriately attached into the mortar joints and not the masonry façade of the building.

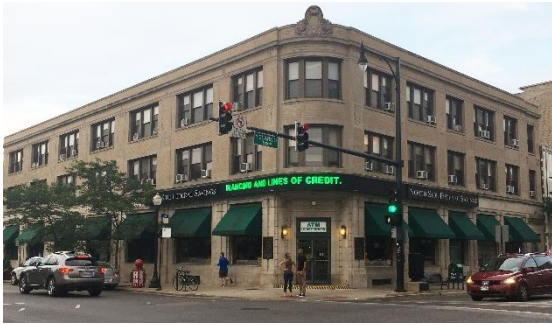
Example of an inappropriate digital banner sign not in the district, that is directly mounted into the building's limestone cladding and obscures architectural features at the first floor.

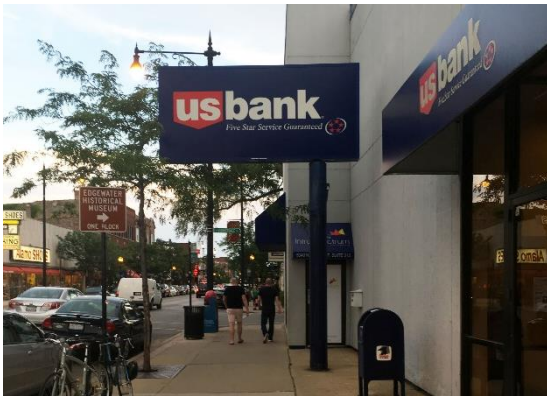
Example of inappropriate freestanding signage not in the district. Signage should not be located in the pedestrian right-of-way.

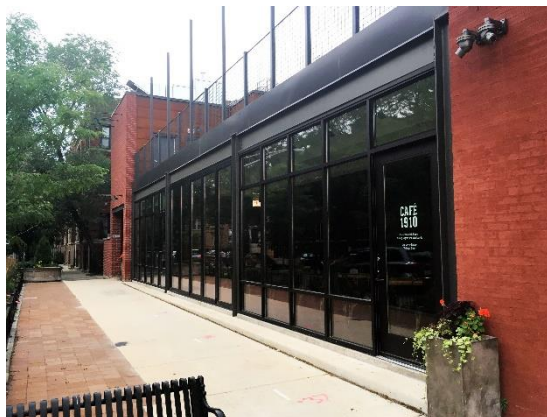
Example of appropriate contemporary rear addition not in the district. It uses contemporary materials and respects the overall scale and shape of the historic building.

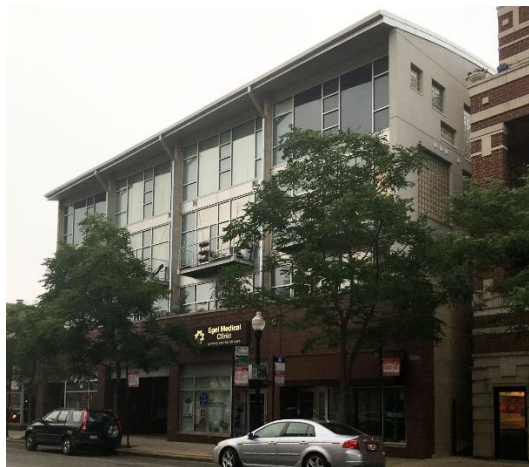
Example of a rooftop addition, located outside of the district, that maintained the building's pedestrian-scale by preserving the historic ground floor storefront, but is incompatible with the historic building due to its scale, and contemporary design and materials.

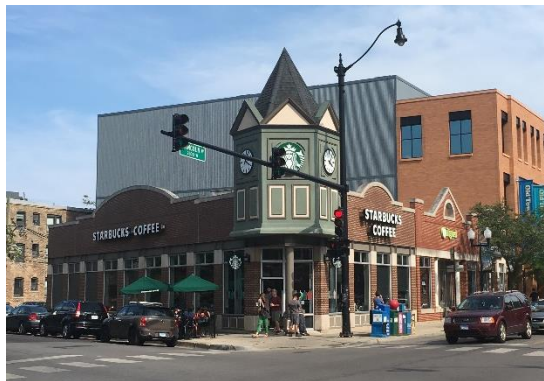
Example of inappropriate new construction not in the district. Design is pseudo-historic and out of scale with its surroundings.

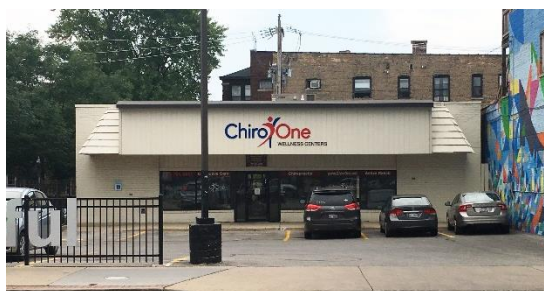
Example of inappropriate non-historic construction not in the district. The building is disproportionate in scale and massing to its surroundings and setback from the street.

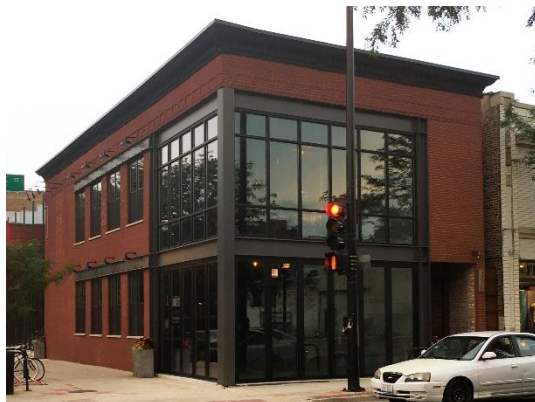
Example of appropriate new development not in the district. The design maintained the scale and massing and reassembled the original masonry material and cornice while integrating a contemporary aesthetic.

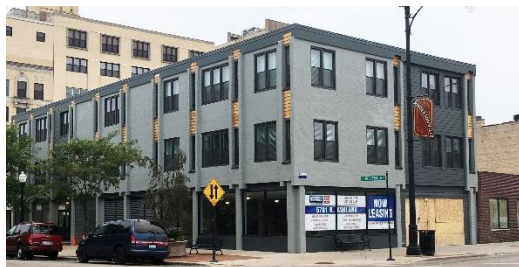
Located outside of the district, this new infill construction maintains an appropriate scale and massing and rhythm of the storefront at the first floor, but uses inappropriate materials such as painted brick and wood shakes and siding.

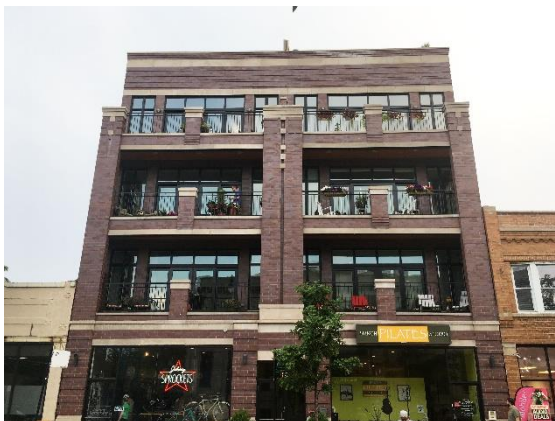
Located outside of the district, this new infill construction maintained the pedestrian-scale of the neighborhood through the incorporation of storefronts at the first floor. It uses compatible materials, but is disproportionate in scale and massing to its surroundings.

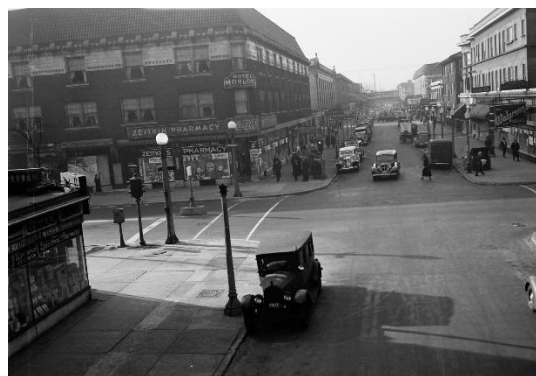
Historic streetscape looking west from Sheridan Road and Argyle Street, December 14, 1936. Note: Lighting Type No. 2 on the left side of the photograph and Type No. 1 in the background. Courtesy of: University of Illinois at Chicago Library, Special Collections Department.

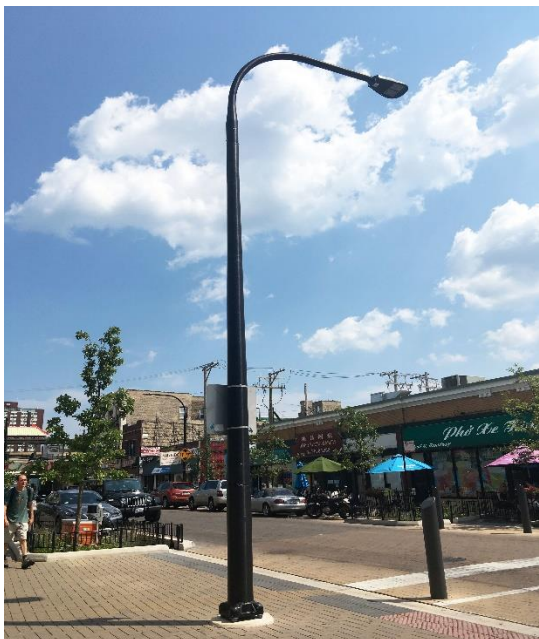
Example of contemporary lighting in the district along Argyle Street.

Lighting in the district today is the contemporary version of the mast-arm post.

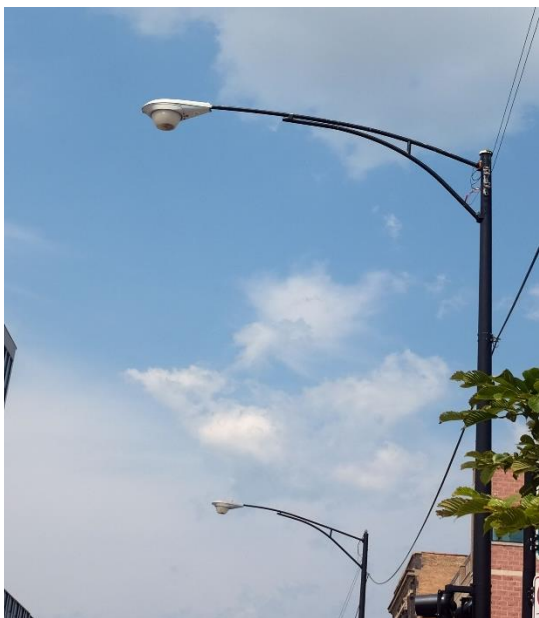
Example of contemporary lighting in the district along Broadway.

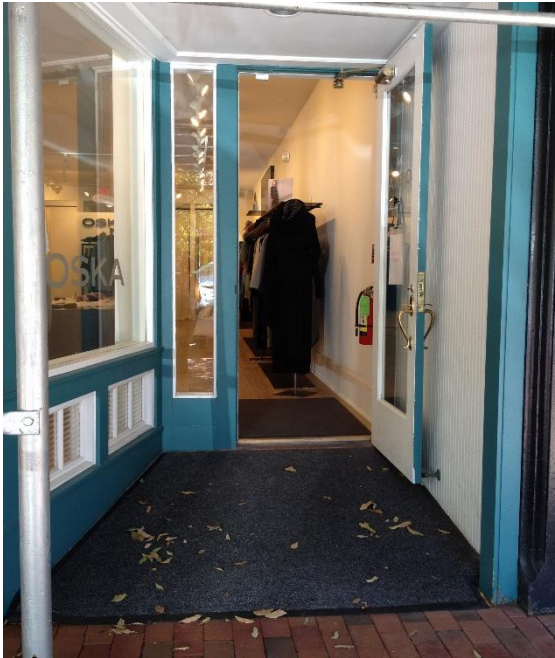
Example of an appropriate contemporary exterior ramp at a front entrance not in the district.

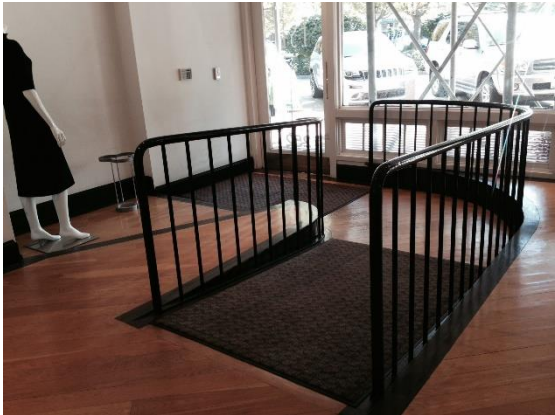
Example of an appropriate contemporary interior ramp within a retail space not in the district.

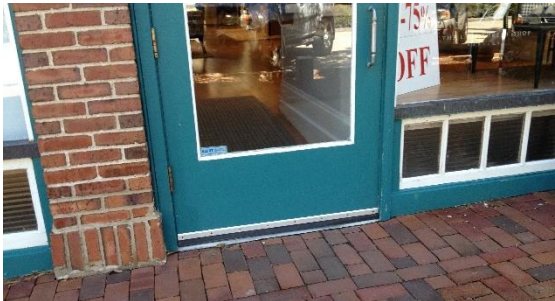
Example of an ADA-compliant threshold not in the district.

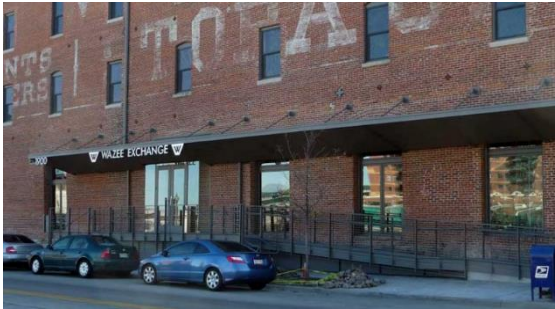
Example of an appropriate contemporary exterior ramp at a side entrance not in the district.
