### Appendix C Environmental Assessment Technical Memoranda

Figure 1-1: Lawrence to Bryn Mawr Modernization Project Build Alternative Map

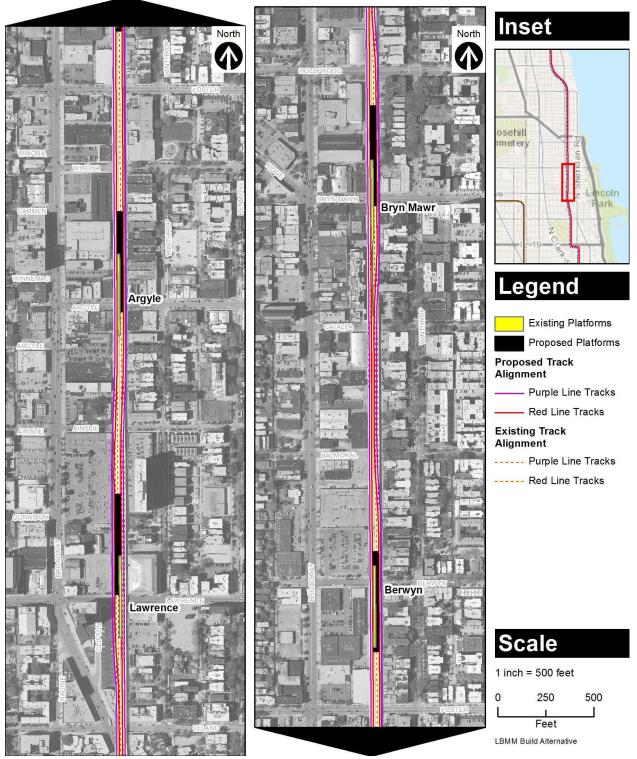
The current track support, referred to as "embankment," was constructed in the 1920s using embankment walls and earth-fill. The embankment supports four tracks (northbound and southbound Red Line tracks, and northbound and southbound Purple Line express tracks). Viaducts would be replaced and no piers would be located in the roadway within the project limits, improving sightlines for pedestrians, drivers, and bicyclists. To meet required vertical clearance over streets and construct the modern support structure, the track profile would be approximately 3 to 10 feet higher than the existing profile. The proposed structure assumes a closed-deck, concrete aerial structure with direct-fixation track and welded rail. Noise barriers (approximately 3 to 3½ feet in height) are proposed on both sides of the track deck to reduce noise transmission at and below track level. To minimize impacts on adjacent properties, the right-of-way widening would take place over adjacent alleys along the east side of the alignment, where possible.

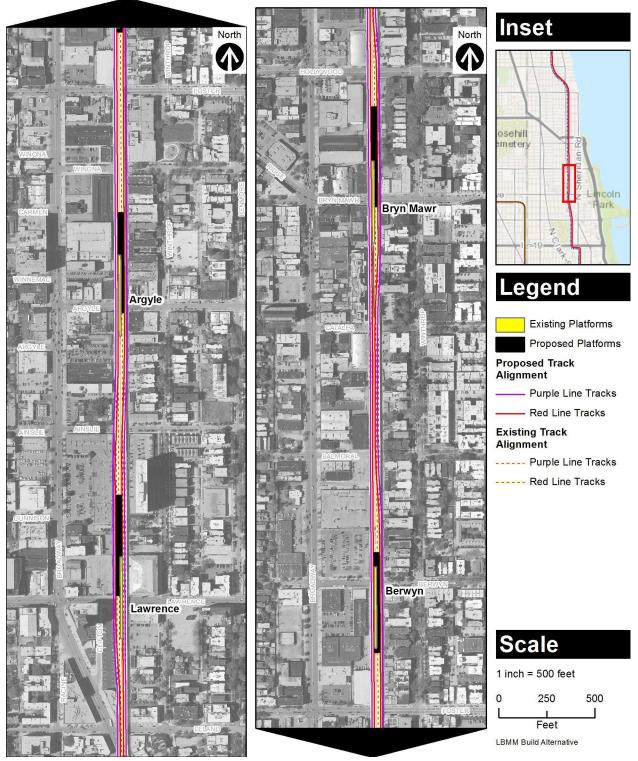
Figure 1-1: Lawrence to Bryn Mawr Modernization Project Build Alternative Map

The current track support, referred to as "embankment," was constructed in the 1920s using embankment walls and earth-fill. The embankment supports four tracks (northbound and southbound Red Line tracks, and northbound and southbound Purple Line express tracks). Viaducts would be replaced and no piers would be located in the roadway within the project limits, improving sightlines for pedestrians, drivers, and bicyclists. To meet required vertical clearance over streets and construct the modern support structure, the track profile would be approximately 5 to 10 feet higher than the existing profile. The proposed structure assumes a closed-deck, concrete aerial structure with direct-fixation track and welded rail. Noise barriers (approximately 3 to 3½ feet in height) are proposed on both sides of the track deck to reduce noise transmission at and below track level. To minimize impacts on adjacent properties, the right-of-way widening would take place over adjacent alleys along the east side of the alignment, where possible.

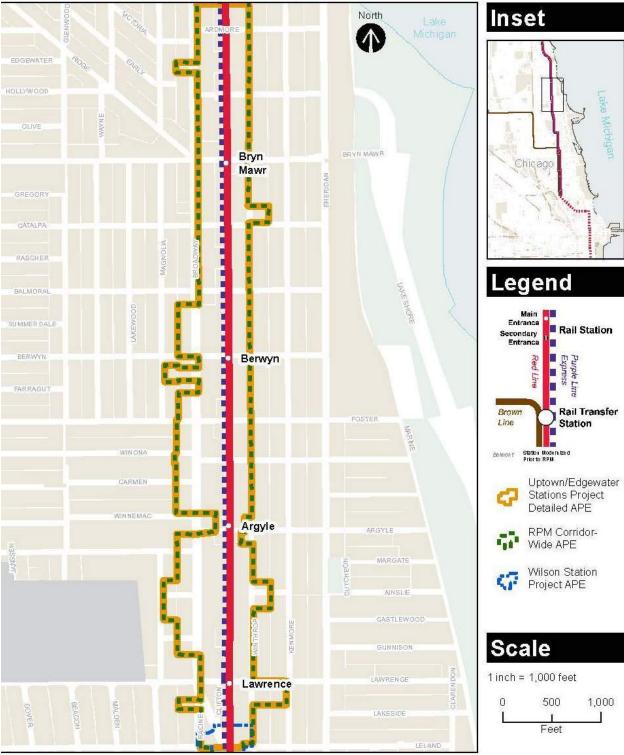
Figure 3-1: Area of Potential Effects Map

In the context of Section 106, the APE is defined as "the geographic area or areas within which an undertaking may directly or indirectly cause alterations in the character or use of historic properties, if any such properties exist" (36 CFR 800.16.d).

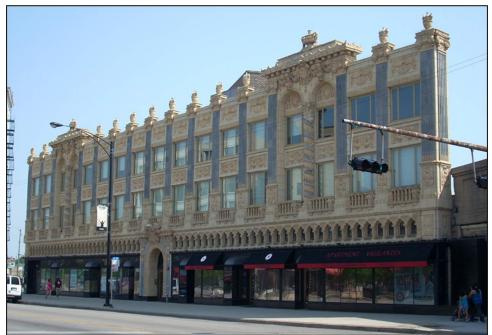
Figure 5-1: West Facade of the Uptown Broadway Building

The Spanish Baroque Revival style Uptown Broadway Building (1926) at 4703-4715 N. Broadway features the most lavish terra cotta facade in the district. Its profusion of detailing includes human faces, animal heads, foliage, spiral columns, and urns rendered in yellow and light blue. The building's architect, Walter Ahlschlager, was already well known in Uptown for his design of the Sheridan Plaza Hotel, another building within the Uptown community area. The Uptown Broadway Building, pictured in **Figure 5-1**, is individually listed on the NRHP and is a contributing element within the Uptown Square Historic District.

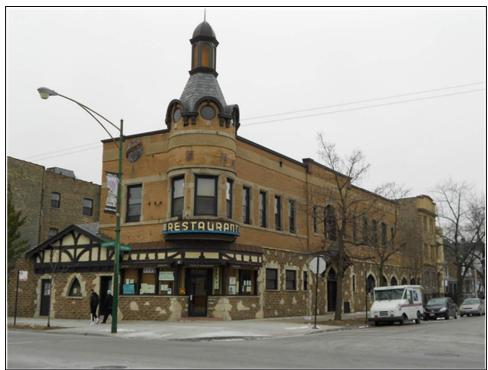
Figure 5-2: Front Facade of the Schlitz Brewery

The former Schlitz Brewery-Tied House at 5120 N. Broadway was constructed in 1904 and is a designated Chicago landmark. Shown in **Figure 5-2**, it is one of the best remaining examples of the architecturally distinctive taverns built by breweries around the turn of the 20th century. Designed in the German Renaissance Revival style by architect Charles Thisslew, the building features a rounded corner turret with porthole windows topped by a lantern. A single-story addition from the 1930s was designed in the Tudor Revival style and extended the building south along Broadway.

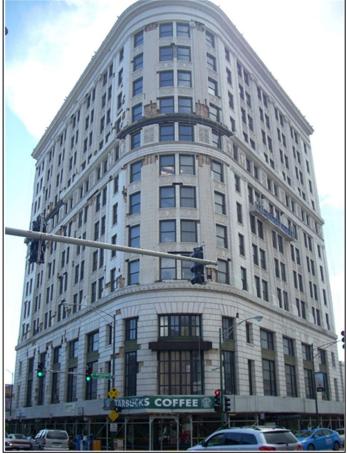
Figure 5-3: View of Sheridan Savings and Trust Bank Building

A rare mid-rise skyscraper in one of Chicago's neighborhood commercial districts, this triangular 12-story building is clad in terra cotta and features a rounded corner. As shown in **Figure 5-3**, storefronts are clad in gray terra cotta and feature Classical detailing that includes pilasters and entablatures with dentil molding and acanthus leaves. The second and third floors feature tall multipaned metal windows that illuminate the banking floor and have green terra cotta spandrels. Above the three-story base, both street elevations display symmetrical fenestration with vertical strips of paired or single one-over-one windows alternating with lonic pilasters. Upper floors are detailed with low-relief ornamentation. Beltcourses are situated above the seventh and eighth floors. The building is visually terminated by a projecting cornice with dentil molding, and displays excellent exterior integrity.

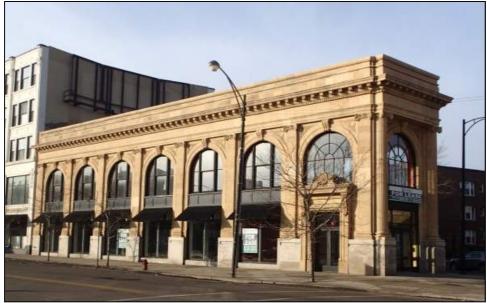
Figure 5-4: Broadway Facade of 4728-4744 N. Broadway Commercial Building

The two-story, limestone commercial building, built in 1914, features elaborate entryways and window detailing with Classical Revival motifs. Additional details include stone pilasters, a cornice with dentil molding, and coping. Shown in **Figure 5-4**, the resource is eligible for NRHP listing under Criterion C as an excellent example of a Classical Revival building in the Uptown community area containing significant stone detailing. In addition, it is considered a contributing resource to the Uptown Square Historic District.

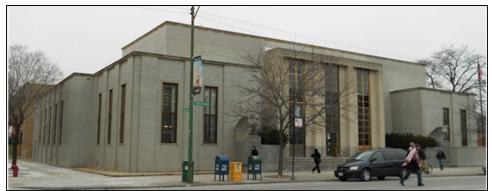
Figure 5-5: East and South Facades of the U.S. Post Office, Uptown Branch

The one-story, flat-roofed Uptown Branch of the U.S. Post Office sits at the northwest corner of Broadway and Gunnison Street in the Uptown community area. The building was designed in the streamlined Art Moderne style by Lewis Simon and was constructed in 1939. Shown in **Figure 5-5**, the building is clad in limestone and has a square footprint. Its front (Broadway) elevation has two flat-roofed projecting wings on either end and a centrally located, limestone-clad, three-bay entrance pavilion that is situated on a podium and accessed via a short flight of stairs. The entrance pavilion features original plate glass double doors trimmed in brass and vertical strips of multipaned windows with brass muntins. Polished granite eagles sit on flanking pedestals. Inside, WPA murals by Henry Varnum Poor depict Carl Sandburg and Louis Sullivan, who holds a model of the Carson Pirie Scott Store.

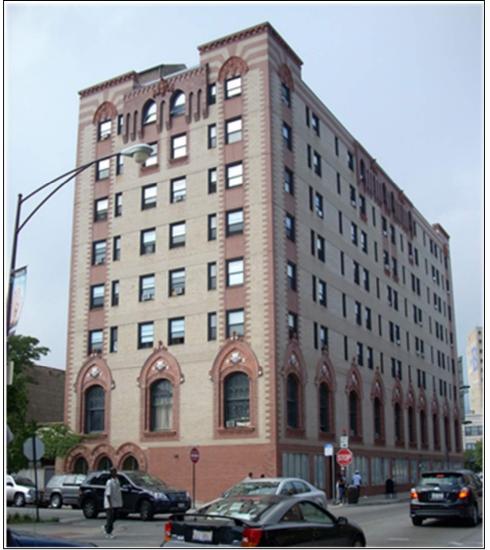
Figure 5-6: North and East Facades of the Wilton Hotel Apartment Building

This eight-story, flat-roofed apartment hotel sits at the northeast corner of Lawrence and Kenmore Avenues in the Uptown community area. Built in 1929, the Venetian Gothic style building features corner pavilions that rise above the parapet. As shown in **Figure 5-6**, its two street elevations are clad in buff-colored brick; brown brick is used for decorative accents in the spandrels, quoins, and parapet. The first floor features a series of display windows along the Lawrence Avenue elevation and a strip of three pointed arch windows on the north end of the Kenmore Avenue elevation. Both elevations feature two-story round arch windows on the second and third floors that have leaded glass, terra cotta rope molding, and pointed arch terra cotta spandrels with cartouches surrounded by voissoirs. Pointed arch terra cotta detailing is also situated above some of the eighth floor windows.

This is a contributing building within the Uptown Square Historic District and is individually eligible for listing on the NRHP under Criterion C for its distinctive architecture. It was rated Orange in the CHRS.

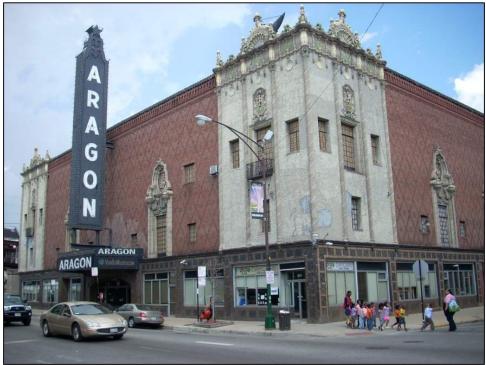
Figure 5-7: South and East Facades of the Aragon Ballroom

As shown in **Figure 5-7**, the building has excellent exterior integrity and features its original storefront configuration along both street elevations, although some storefronts along Winthrop

have been infilled with brick. Storefronts are surrounded with terra cotta cladding and feature nonoriginal glass doors and windows. The original curved entrance to the ballroom is situated along the Lawrence Avenue elevation. The upper two floors are clad with face brick featuring diaper patterns and the corner pavilions are clad in stucco. Original multipaned windows are extant; exuberant Spanish Revival detailing includes rope molding, scallop shells, cartouches, and metal balconettes. Corbelling is situated along the roofline. The current marquee and canopy are nonoriginal. This is a contributing building within the Uptown Square NRHP Historic District and was rated Orange in the CHRS. It is also individually eligible for listing on the NRHP under Criterion C.

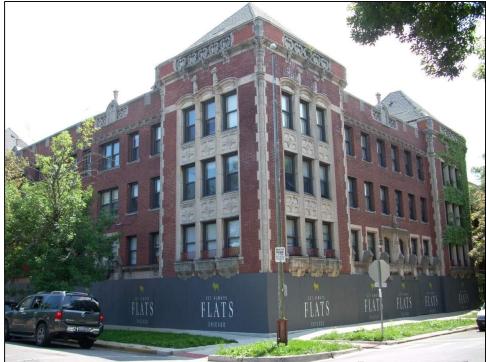
Figure 5-8: North and West Facades of 4875 N. Magnolia Avenue Apartment Building

This four-story Gothic Revival style apartment building at the southeast corner of Magnolia Avenue and Ainslie Street was built in 1927. It has corner pavilions with pyramidal roofs that rise above its brick and stone balustrade. The street elevations are clad in face brick and have one-over-one windows. Decorative detailing in stone includes quoins, spandrels, window hoods, rooftop urns, rope molding, and griffins. Second floor windows on the corner pavilions have metal balconettes. The building, shown in **Figure 5-8**, is individually eligible for listing on the NRHP under Criterion C due to its fine overall integrity and plethora of decorative detailing.

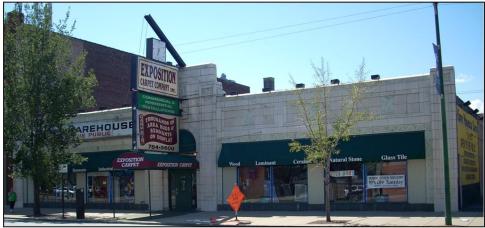
Figure 5-9: East Facade of Art Moderne Commercial Building at 5718 N. Broadway

This one-story, Art Moderne style commercial building in the Edgewater community area was designed by Edwin F. Gillette and built in 1922. As shown in **Figure 5-9**, it has a front facade clad in cream-colored terra cotta, a flat roof, and stepped parapet. Its centrally located entrance has a non-original door with sidelights and a transom, flanked by display windows on either side. Flattened decorative reliefs featuring zigzag, floral, and wave motifs in cream and green terra cotta frame the storefront bays and the entrance and are situated along the parapet level. Stylized panels featuring mermaid motifs are situated above the entrance, partially obscured by the installation of non-original signage.

The building was rated Orange in the CHRS. Installation of signs and awnings has adversely affected some of the terra cotta; this is, however, an unusual example of an Art Moderne style commercial building in Edgewater. It has good integrity in terms of its terra cotta cladding and stylized motifs. The building is therefore individually eligible for listing on the NRHP under Criterion C given its unique terra cotta forms and the rarity of the Art Moderne style buildings in Edgewater.

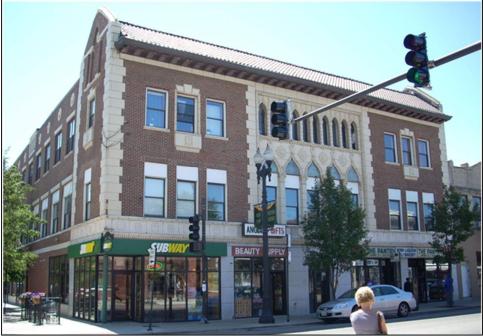
Figure 5-10: Front Facade of Mixed-Use Building at 1101-1107 W. Bryn Mawr Avenue

by Raymond Gregori and built in 1927, is shown in **Figure 5-10**. The two street elevations are clad in brown brick and have detailing in cream-colored terra cotta including a frieze band with quatrefoils and shields, quoins, and lintels. The central portion of the Bryn Mawr elevation features windows with pointed arch transoms at the second story level and a series of lancet windows at the third story level, with medallions in the spandrels between. The one-over-one windows along both street elevations appear to be non-original aluminum sash; storefronts have non-original glass doors and display windows.

The Bryn Mawr NRHP Historic District nomination form identifies this recreational building which originally featured billiards rooms with offices above—as a "pivotal building within the district." In addition to being a contributing resource within the Bryn Mawr NRHP Historic District, it is individually eligible for NRHP listing under both Criteria A and C.

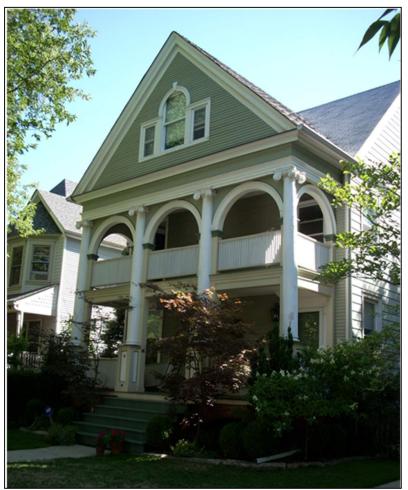
Figure 5-11: Front Facade of Classical Revival Style Residence at 5247 N. Magnolia Avenue

This Classical Revival style house in the Edgewater community area is 2.5 stories in height and has wood clapboard siding, a cross-gable roof with asphalt shingles, and a frieze band across the front facade. Built in 1898, the house was designed by Harvey L Page and Company. As shown in **Figure 5-11**, the front gable features a Palladian window in the gable; other windows are one-over-one wood sash with wood casings. The front facade is dominated by a two-story wood porch with a balcony above, which has two-story Ionic columns and straight railings. The off-center front door has a Classical surround with fluted pilasters and entablature.

This is a contributing building within the Lakewood Balmoral Historic District. The residence is also eligible for individual inclusion on the NRHP under Criterion C because it has excellent integrity and is an unusual example of Classical Revival in the Edgewater community area and within the historic district. The house was rated Orange in the CHRS.

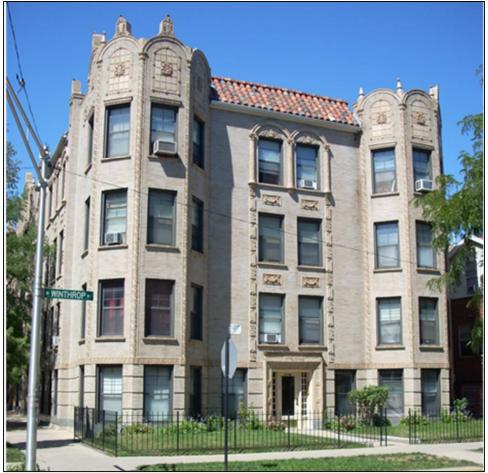
Figure 5-12: East Facade of the Rose, a Spanish Revival Apartment Building

Shown in **Figure 5-12**, this building has excellent integrity and a wealth of detailing in the Spanish Revival style, which is not exceedingly common for apartment designs in Chicago. It is individually eligible for listing on the NRHP under Criterion C.

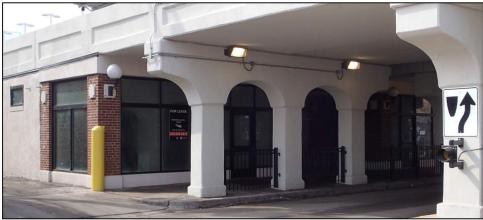
Figure 6-1: View of 1117-1119 W. Argyle Street

**Direct Effects**: The Build Alternative would require demolition of the vacant CTA-owned retail spaces beneath the track structure on the south side of Argyle Street (1117-1119 W. Argyle Street), which is identified as contributing within the district. The commercial spaces are shown in **Figure 6-1**.

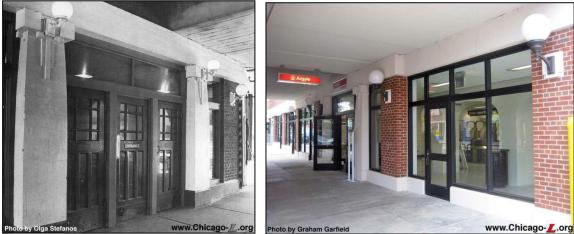
Figure 6-2: Views of Facade of Argyle Station

Further, CTA's Argyle station (a contributing resource to the district) would be reconstructed, potentially resulting in an adverse effect. If conceptual designs can be refined to be consistent with the SOI *Guidelines for Rehabilitation* and the SHPO concurs, the impacts to the resource may not be adverse. Specifically, the facade of the station house should be preserved. Input from consulting parties indicated that the pilasters are a key feature and should be incorporated into station design plans; the exterior light fixtures and any other salvageable original materials were also identified for potential reuse as part of the rebuilt station. **Figure 6-2** shows photos of the stationhouse facade circa 1985 (left), when it remained largely intact to its original construction, and in 2012 (right) after its most recent renovation.

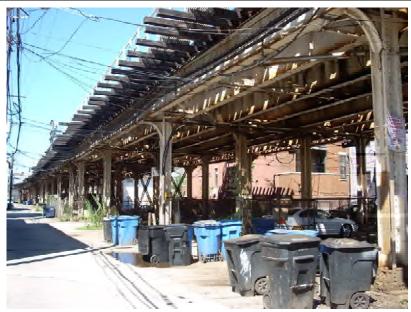
Individually Eligible? YesABCSignificance: A: Key element in the development of the north side of Chicago (entire length in RPM APE) C: Good example of the new riveted steel plate technology (Belmont to Montrose Avenues)
--

Steel structure near Belmont Station

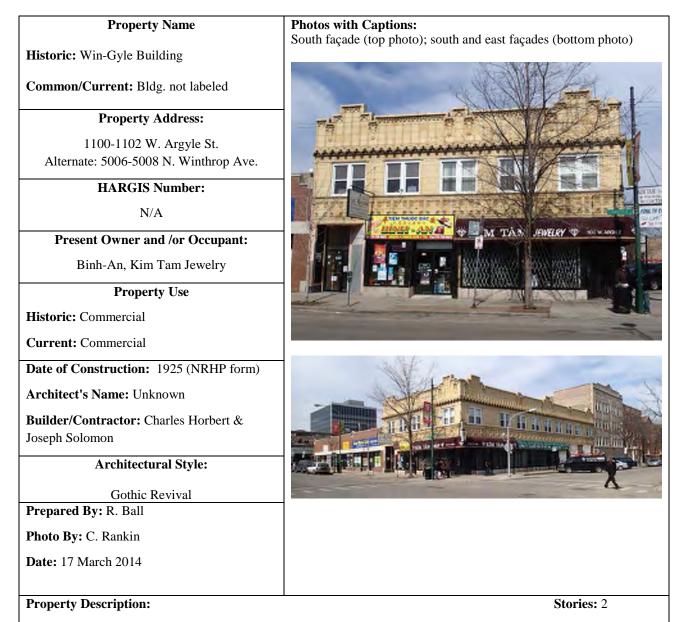
This two-story commercial building is located in the Uptown neighborhood. It is topped by a flat roof and stepped parapet with terra cotta detailing. The building is clad in terra cotta on its façade. Detailing includes terra cotta quatrefoils, shields, decorative tracery, and coping. Windows and entry doors are contemporary replacements.

The property does not exhibit sufficient integrity as a result of contemporary alterations, which include storefront alterations, replacement windows and entry door. As a result, the property does not qualify as individually eligible for listing on the National Register of Historic Places. However, it is considered a contributing resource to the West Argyle Street Historic District

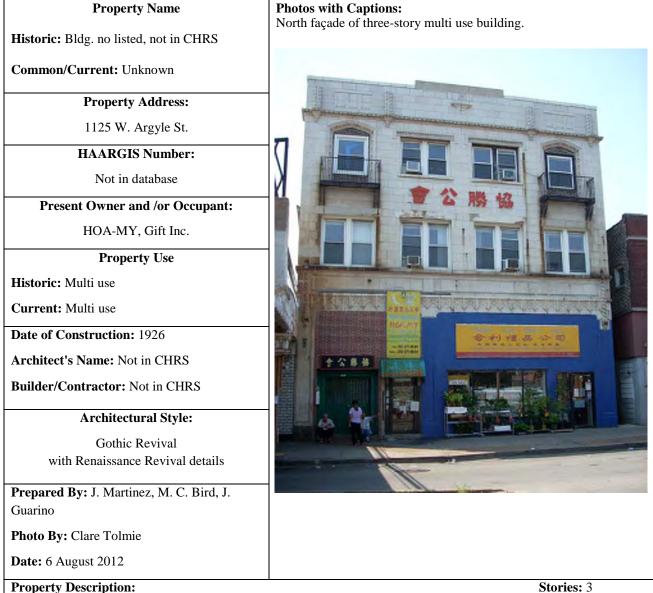
This three-story building in the Uptown Neighborhood is clad in cream-colored terra cotta and has a flat roof with parapet. The storefront fixed-pane display windows and glass doors are non-original. Upper floor windows are double-hung aluminum sash. Detailing includes balconettes, a stringcourse (third story), and geometric motifs in terra cotta spanning the ground floor level.

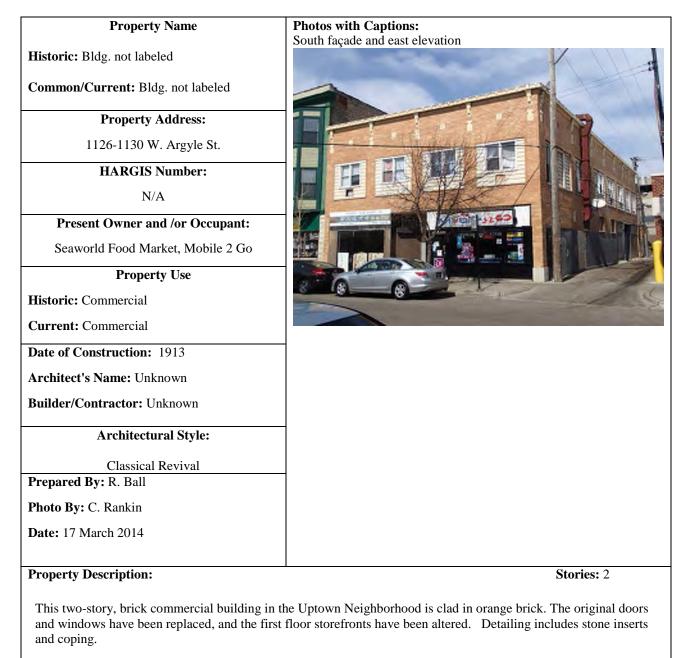
This building lacks sufficient integrity and distinguishing architectural features to qualify as individually eligible for listing on the National Register. While the building falls within the West Argyle Street Historic District, it is identified in the nomination form as non-contributing due to its loss of historic fabric.

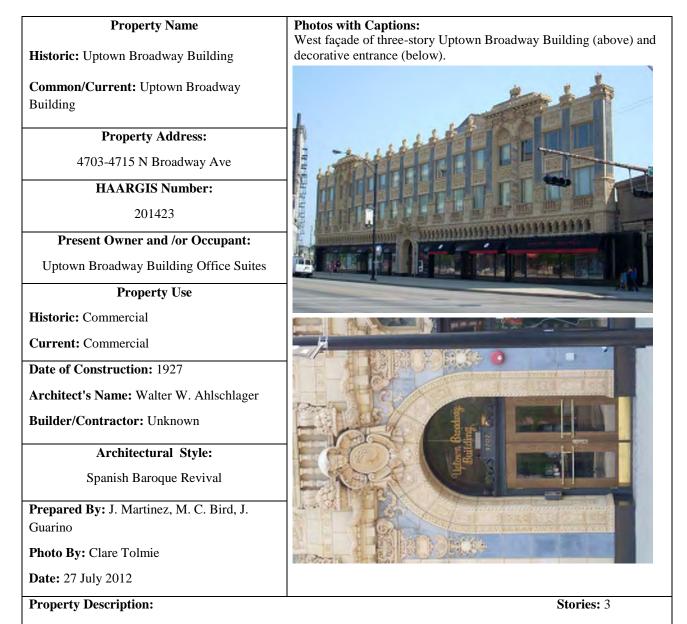
The Uptown Broadway Building is a three-story store and office building with a triangular footprint and flat roof that is situated near the northeast corner of Leland Avenue and Broadway in the Uptown Neighborhood. The front (Broadway) façade is entirely clad in glass and polychrome terra cotta (pale ochre and light blue) and is divided into seventeen bays. The round-arched centrally located entrance and upper floors feature exuberant Spanish Baroque Revival style detailing that includes rams' heads, shields, cartouches, birds, floral swags, spiral columns, flowers, and strapwork. The first floor retains its original storefront configuration with plate glass windows and metal door and shopfront trim. The upper floors feature two-story pilasters and Chicago windows featuring a large main light and side lights. The roofline is topped by Classical urns.

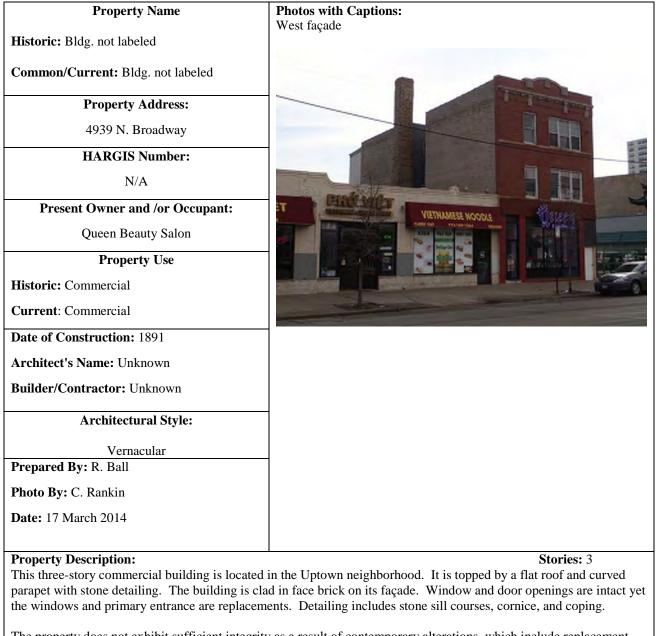
The property does not exhibit sufficient integrity as a result of contemporary alterations, which include replacement windows and primary entry door. A typical example of a commercial building from its era, the property does not exhibit distinguishing architectural features to qualify as individually eligible for listing on the National Register of Historic Places.

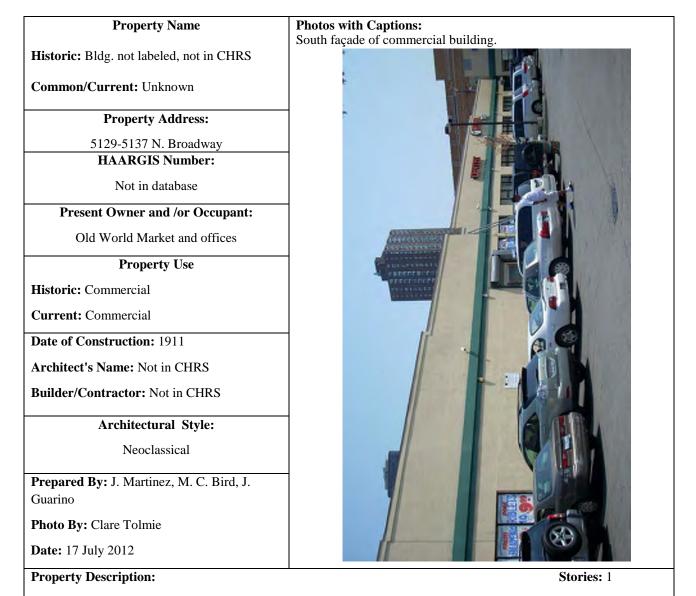
This one-story building has a flat roof with parapet. The north half of the front (Broadway) façade of the building is clad in stone and has Classical detailing at the roofline, including urns and a frieze band. The south half of the front (Broadway) elevation and the south elevation of the building facing the parking lot is clad in a synthetic material. Alterations include altered storefronts on Broadway and new display windows and entrance doors along the south (parking lot) elevations. This building does not possess sufficient distinguishing architectural features qualify as individually eligible for listing on the National Register.

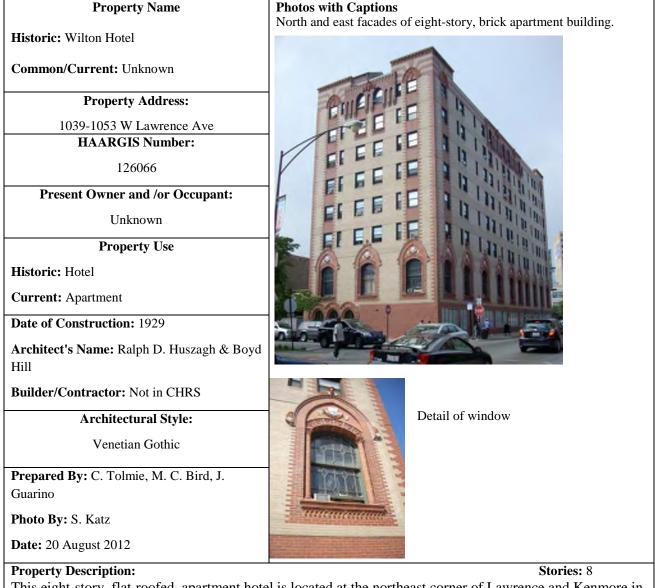
This eight-story, flat-roofed, apartment hotel is located at the northeast corner of Lawrence and Kenmore in the Uptown neighborhood. The Venetian Gothic style building features corner pavilions that rise above the parapet. Its two street elevations are clad in buff-colored brick and brown brick is used as decorative accents in the spandrels, quoins, and as banding at the parapet level. The first floor features a series of display windows along the Lawrence elevation, and a strip of three pointed arch windows on the north end of the Kenmore elevation. Both elevations feature two-story round-arched windows on the second and third floors that have leaded glass, terra cotta rope molding, and pointed-arch terra cotta spandrels with cartouches surrounded by voissoirs. Pointed-arch terra cotta detailing is also situated above some of the eighth-floor windows. The one-over-one windows appear to be original wood sash. This is a contributing building within the Uptown Square National Register Historic District and is recommended as individually eligible for listing on the National Register.

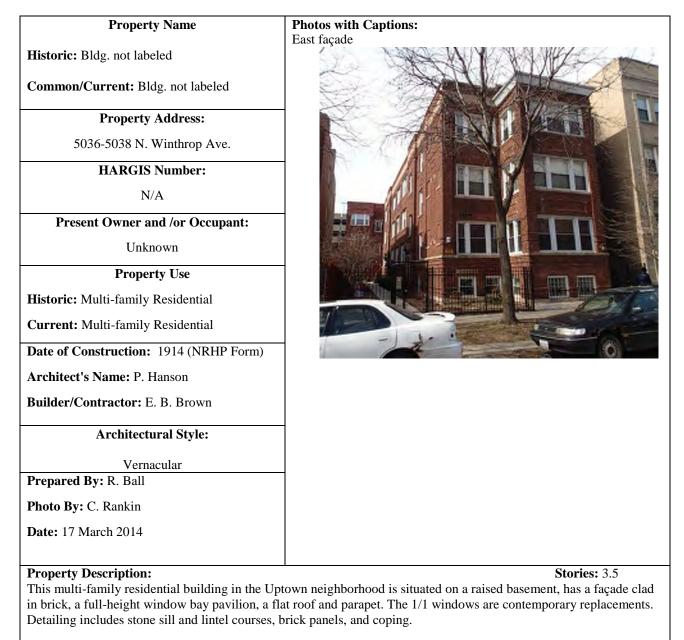
This building does not possess significant architectural characteristics to distinguish it as individually eligible for listing on the National Register of Historic Places. However, it is a contributing resource within the West Argyle Street Historic District.

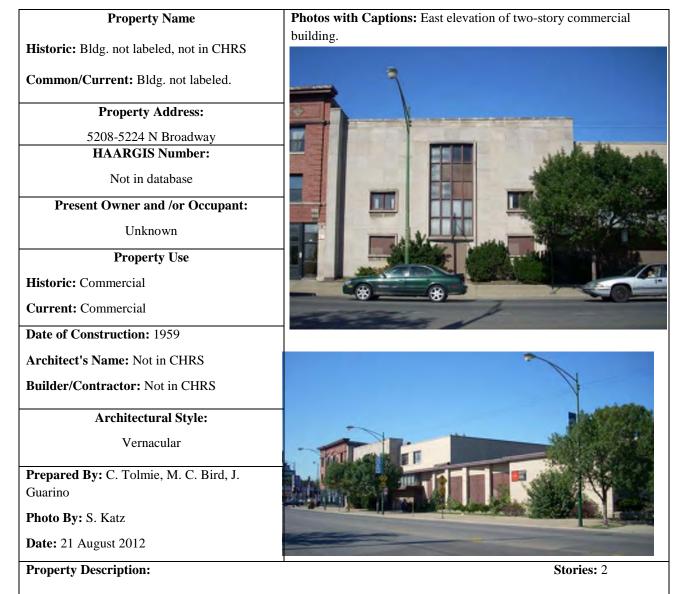
This two-story, flat-roofed commercial building in the Edgewater neighborhood has a front façade clad in smooth limestone and adjacent two- and one-story wings to the north clad in buff-colored brick. The limestone-clad building has a centrally located entrance flanked by a window opening on each side, all of which have been boarded-up. Above the entrance is a tall, multi-paned bay window with frosted glass. The second story has two paired casements. The two-story wing has an entrance bay that has been boarded-over, a strip of casements above, and paired awning windows. Window openings on the one-story wing have been boarded-over. This building does not possess sufficient distinguishing architectural characteristics to distinguish it as individually eligible for listing on the National Register.

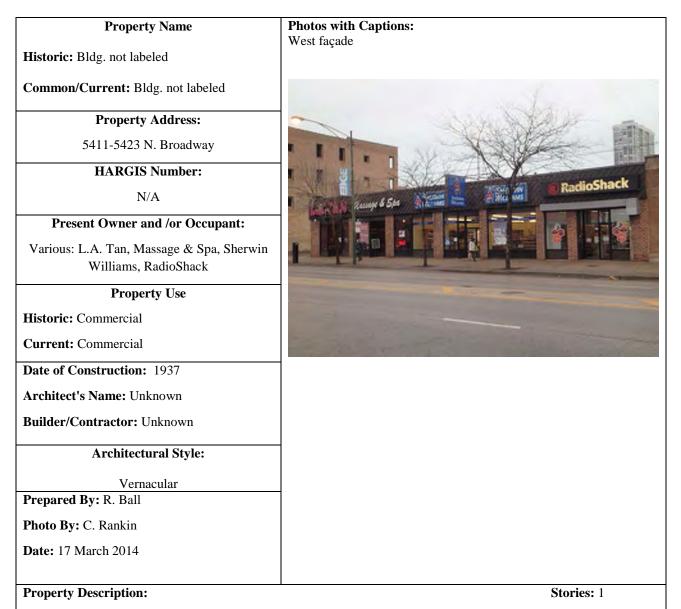
This one-story commercial building in the Uptown neighborhood has a façade clad in face brick and topped by a flat roof. The upper third of the front façade has a prominent parapet with contemporary store signage. Storefronts are substantially altered with new display windows and glass doors.

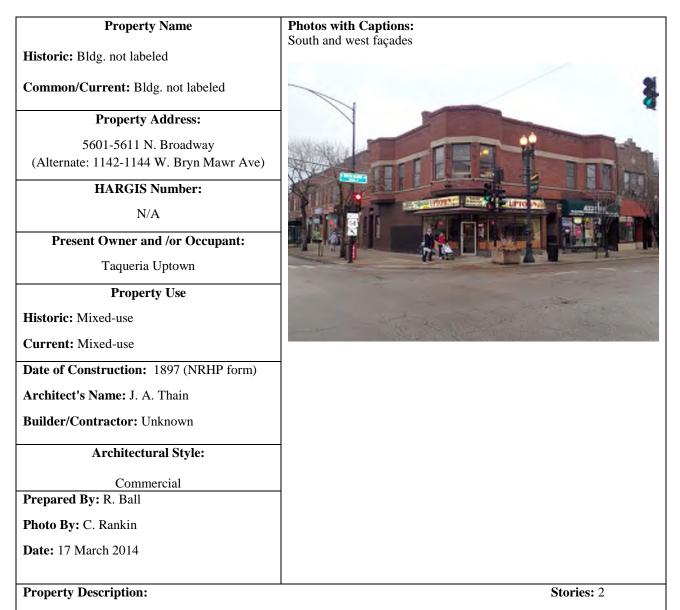
This two-story mixed-use building is located in the Edgewater neighborhood. It is topped by a flat roof and parapet. The building is clad in face brick on its façade. First floor window and door openings are intact yet the windows and primary entrance are replacements. Three second-story window bays are present. Detailing includes stone sill and lintel courses, and coping.

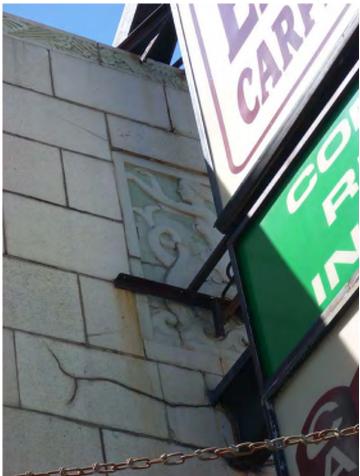
Property Name	Photos with Captions:
Historic: Bldg. not labeled	West façade
Common/Current: Bldg. not labeled	
Property Address:	
5733-5739 N. Broadway	
HARGIS Number:	
N/A	
Present Owner and /or Occupant:	
Public Storage	
Property Use	
Historic: Commercial	
Current: Commercial	
Date of Construction: 1938	
Architect's Name: Unknown	
Builder/Contractor: Unknown	
Architectural Style:	
Vernacular	
Prepared By: R. Ball	
Photo By: C. Rankin	
Date: 17 March 2014	
Property Description:	Stories: 2
This two story commercial building is located	in the Edgewater neighborhood. It is topped by a flat roof and parapet

This two story commercial building is located in the Edgewater neighborhood. It is topped by a flat roof and parapet and clad in concrete on its facade. Detailing includes arched doorways, panels, and stylized pilasters. Windows are fixed pane and along with entry doors are contemporary replacements.

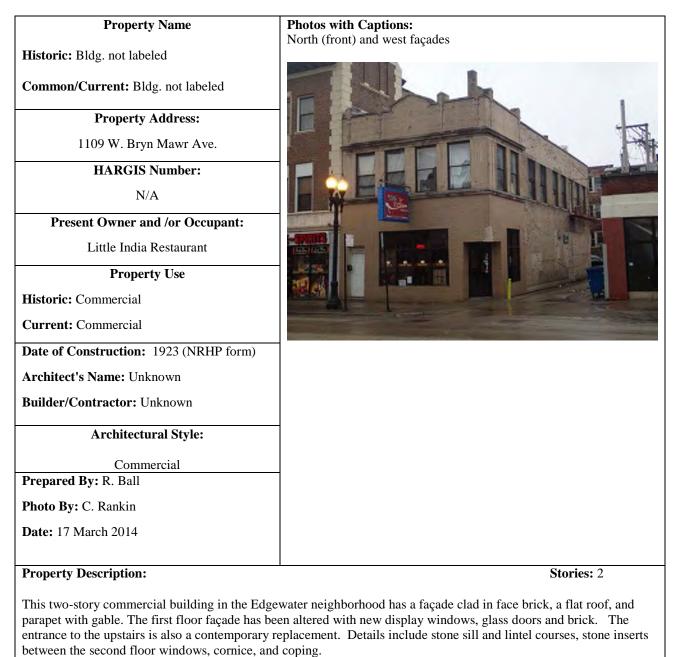
The property lacks distinguishing architectural features and has experienced a loss of architectural integrity due to alterations. The property does not qualify as individually eligible for listing on the National Register of Historic Places. However, it is considered a contributing resource to the Bryn Mawr Historic District.

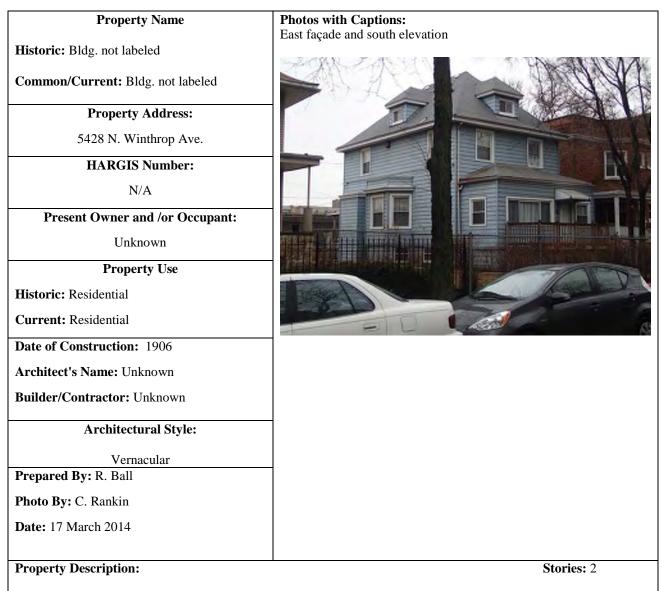
This two-story house in the Edgewater neighborhood is clad in aluminum siding and is topped by a hip roof covered in asphalt shingles. Hip dormers adorn three faces of the roof. Each contains a single window. A full width porch, topped by a hip, roof adorns the façade. It has been fully enclosed and contains contemporary replacement windows and entry door. A set of replacement wood stairs leads to wood deck located in front of the porch. The windows are double-hung, contemporary replacements. Replacement wood railings are present.

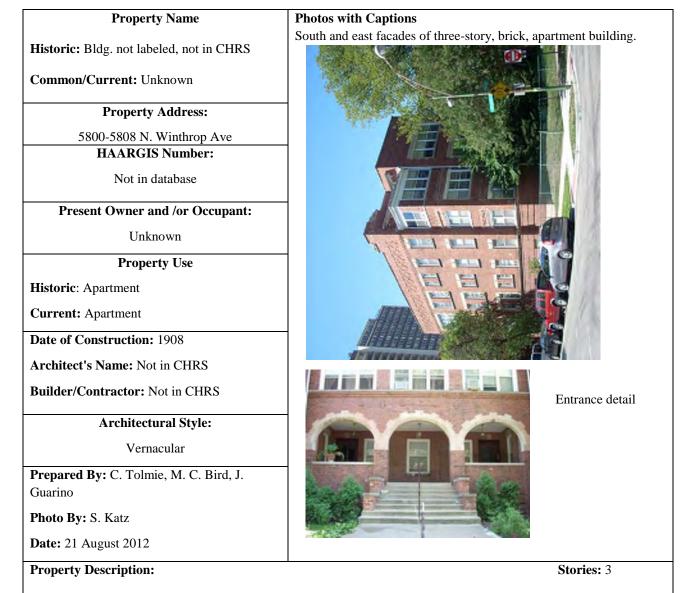
This three-story apartment building at the northwest corner of Winthrop and Ardmore in the Edgewater neighborhood is situated on a raised basement. It has two street elevations clad in reddish-brown face brick, a flat roof and parapet. Its front (Winthrop) elevation has a centrally locate triple-arched brick porch accessed via a flight of concrete steps with two original single-light oak doors with keystones. The building's one-over windows appear to be original wood sash. Decorative detailing includes stone sills, sill courses, and lintels as well as brick banding, corbelling, and decorative brickwork along the Ardmore elevation's parapet level. This building does not possess sufficient distinguishing architectural characteristics to qualify as individually eligible for listing on the National Register.
